Rose Elementary School

Douglas County SD 4

FEMA 154 Rapid Visual Screening Score Card

Rapid Visual Screening - Senate Bill #2 - Seismic Needs Assessment
Oregon Department of Geology and Mineral Industries

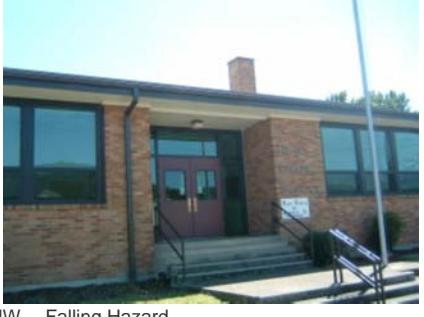
| | | | <p>NW Falling Hazard chimney reinforced?</p> <p>SW General Site</p> <p>S Plan Irregularity Primary step in elevation also</p> |

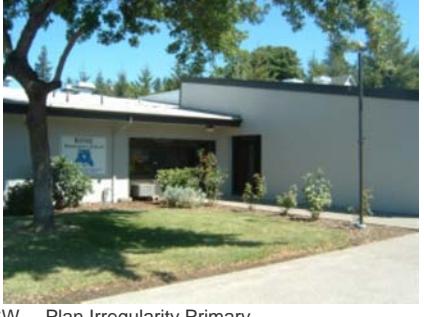
| SW Plan Irregularity Primary step in elevation also | | SE General Site | |

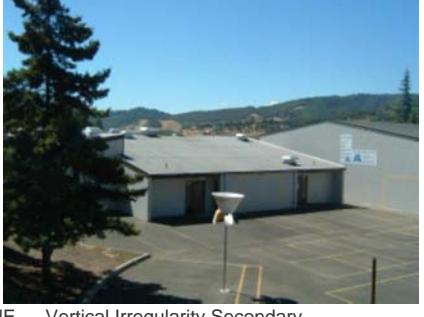
| | | NE Vertical Irregularity Secondary reentrant corner also | |
