# John C Fremont Middle School

Douglas County SD 4

## FEMA 154 Rapid Visual Screening Score Card

Rapid Visual Screening - Senate Bill #2 - Seismic Needs Assessment  
Oregon Department of Geology and Mineral Industries

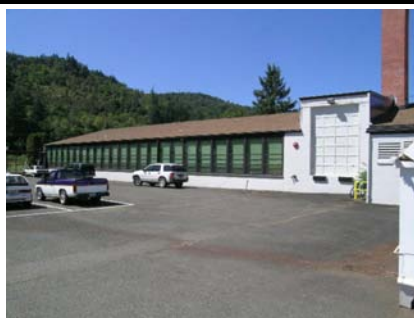
E Falling Hazard  
URM

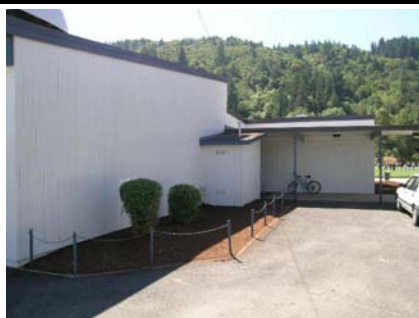
NW Vertical Irregularity Primary  
and reentrant corner

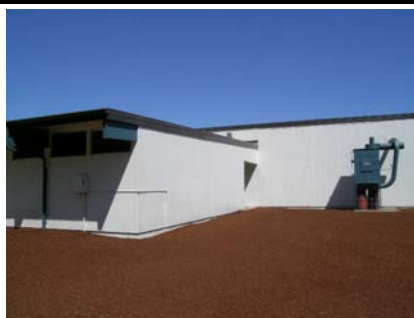
SE Plan Irregularity Primary  
and step in elevation

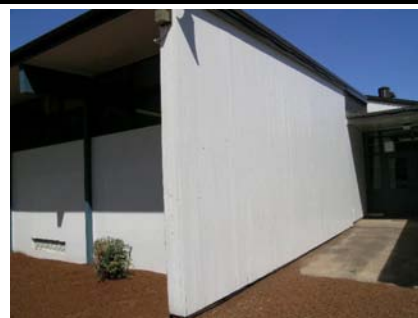
SW Tertiary Structural Type

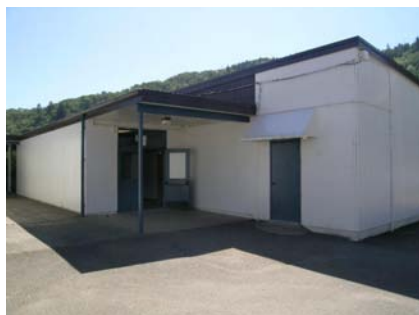
NW Vertical Irregularity Primary  
and reentrant corner

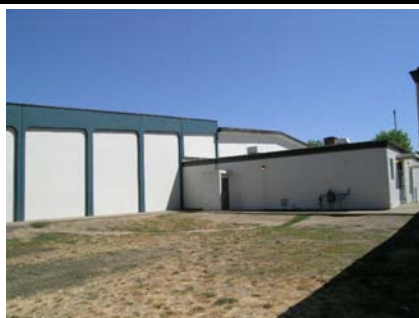
SW Vertical Irregularity Primary  
and reentrant corner

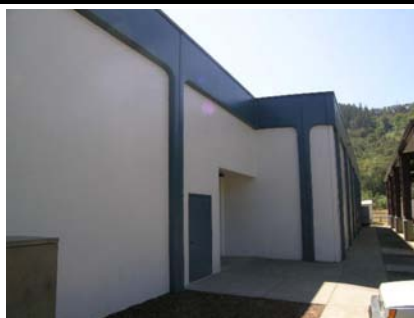
NW Primary Structural Type  
and out-of-plane offset

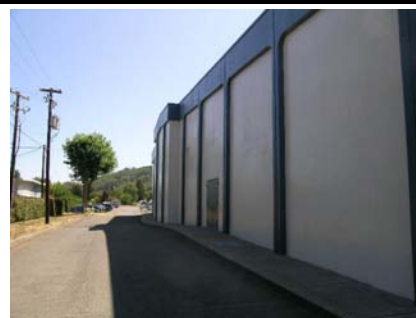
NW Plan Irregularity Secondary
