Joseph Lane Middle School

| RVS in 2006 | | 8/25/2006 | |

FEMA 154 Rapid Visual Screening Score Card

Rapid Visual Screening - Senate Bill #2 - Seismic Needs Assessment
Oregon Department of Geology and Mineral Industries

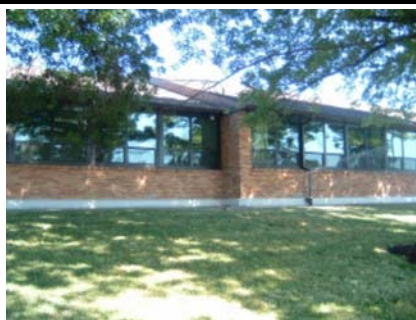
W Plan Irregularity Tertiary

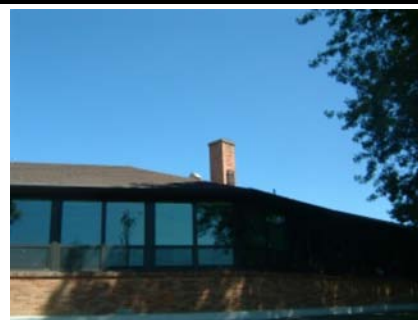
W Falling Hazard
reinforced chimney?

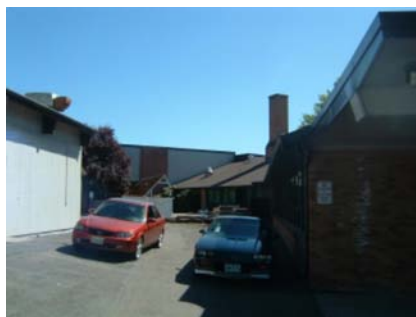
N Plan Irregularity Primary
steps in elevation also

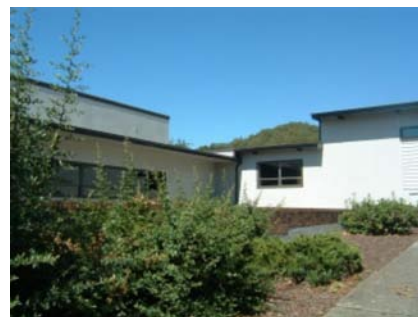
SW Vertical Irregularity Primary
reentrant corner also
