Glide Elementary School

Glide SD 12

FEMA 154 Rapid Visual Screening Score Card

Rapid Visual Screening - Senate Bill #2 - Seismic Needs Assessment
Oregon Department of Geology and Mineral Industries

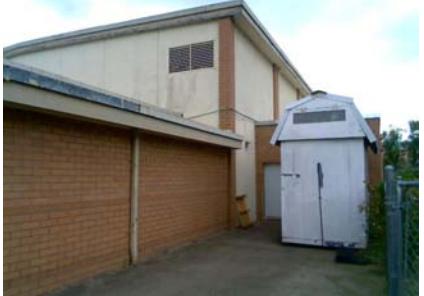
Enrollment 349	Year Built (Field Verified) 1963	Year Built (Alt. Source) 1963	Est. Decade Built 1960
Total Area (square ft) 52180	Number of Stories 1	Basement	Pounding Potential No
Plan Irregularities Reentrant Corners: Other None None		Vertical Irregularities Steps in Elevation View: Single Change None None	
Falling Hazards None None None		Poor Conditions None None None

<p>NE Vertical Irregularity Primary and reentrant corner.</p>
