# Canyonville School

Doug\_sch13A

## FEMA 154 Rapid Visual Screening Score Card

Rapid Visual Screening - Senate Bill #2 - Seismic Needs Assessment  
Oregon Department of Geology and Mineral Industries

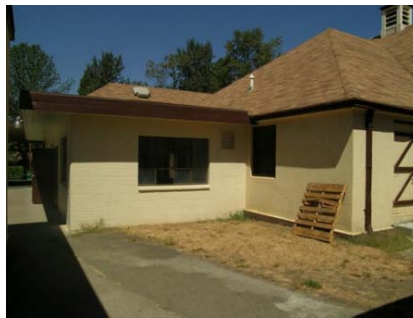
N Poor Condition

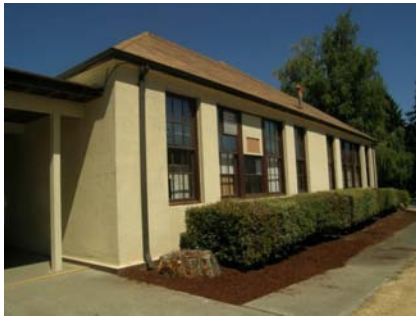
SW Falling Hazard  
reinforced?

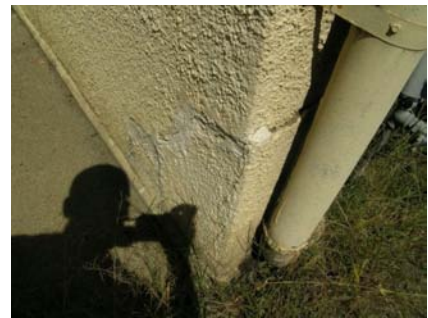
Falling Hazards	Poor Conditions
None	Cracks
None	None
None	None

SW Poor Condition

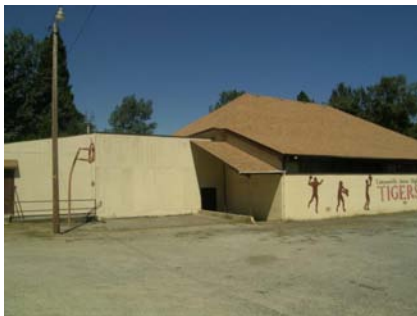
S Vertical Irregularity Primary  
and reentrant corner

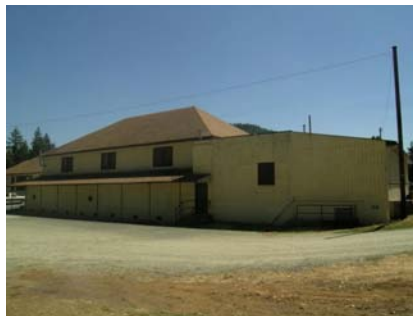
N Vertical Irregularity Primary

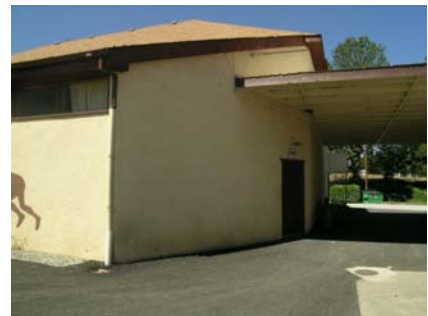
SE Plan Irregularity Secondary
