Myrtle Creek Elementary School

South Umpqua SD 19

FEMA 154 Rapid Visual Screening Score Card

Rapid Visual Screening - Senate Bill #2 - Seismic Needs Assessment
Oregon Department of Geology and Mineral Industries

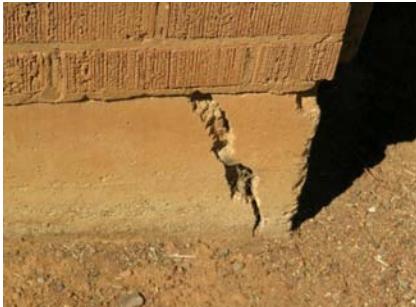
SE Poor Condition

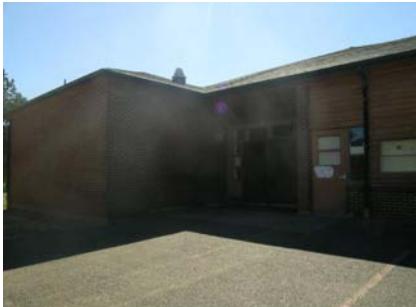
NE Plan Irregularity Secondary

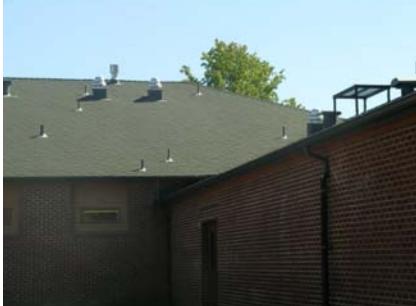
N Vertical Irregularity Primary

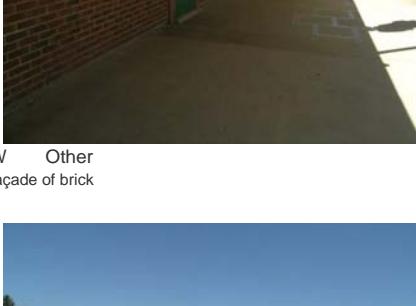
W Other façade of brick

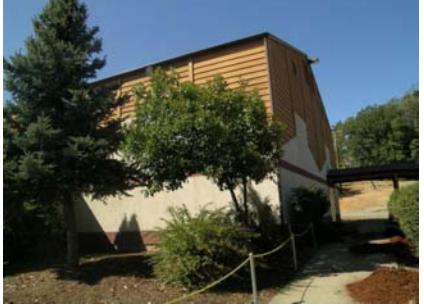
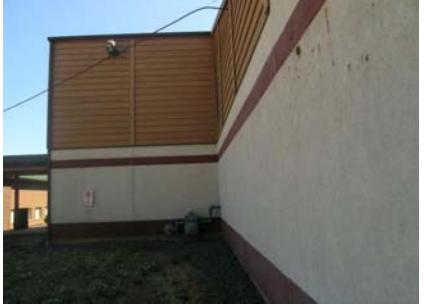
SE Elevation View		NE Plan Irregularity Primary

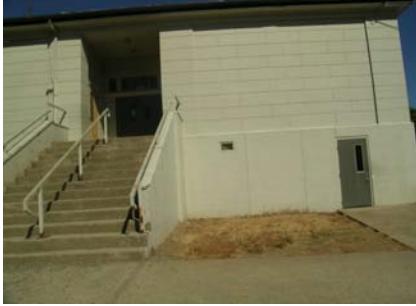
N Basement	NW Plan Irregularity Primary	W Elevation View

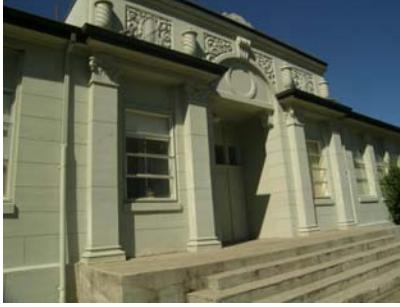
S Number of Stories	S Falling Hazard	N Falling Hazard

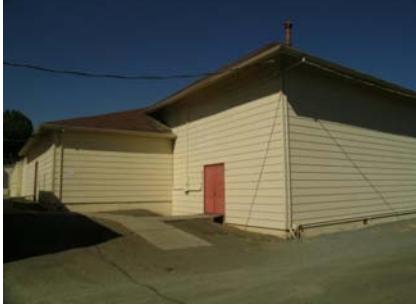
SW Plan Irregularity Primary

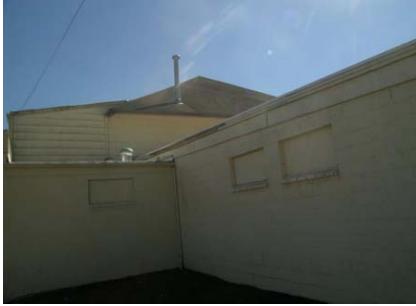
NE Vertical Irregularity Primary and reentrant corner

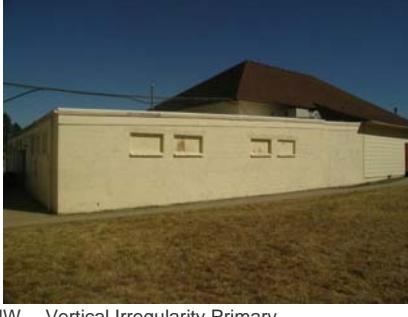
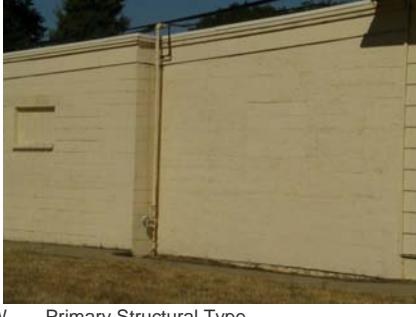
S Other Falling Hazard due to nearby URM smokestack near this building. NOTE: this image is not the building being screened. The boiler room shown was not s	NW Vertical Irregularity Primary	W Primary Structural Type
