# Riddle High School

Doug\_sch21A

## FEMA 154 Rapid Visual Screening Score Card

Rapid Visual Screening - Senate Bill #2 - Seismic Needs Assessment  
Oregon Department of Geology and Mineral Industries

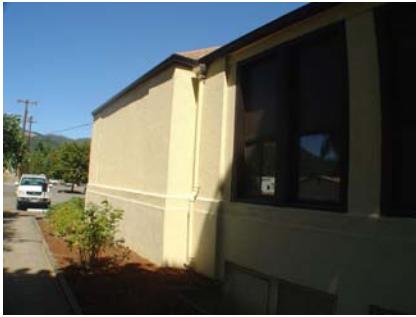
W Plan Irregularity Secondary

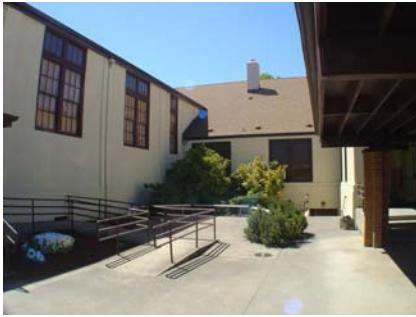
E Falling Hazard

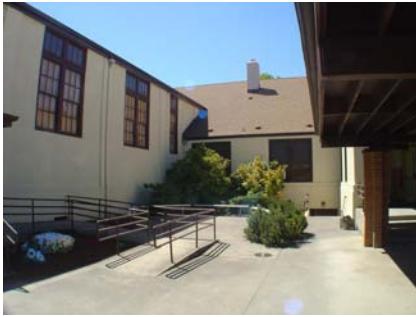
E Plan Irregularity Primary

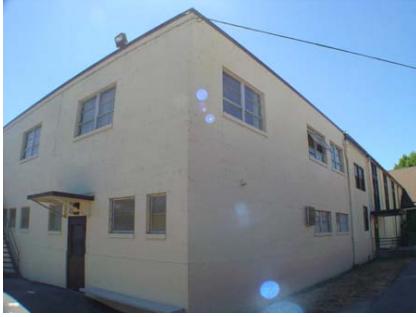
NE Primary Structural Type

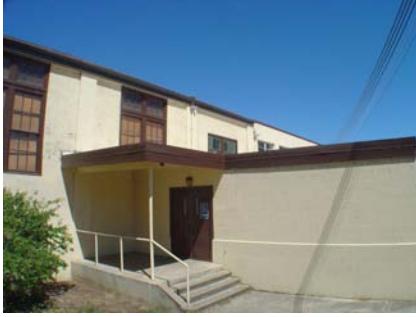
S Plan Irregularity Tertiary step in elevation with adjacent bldg

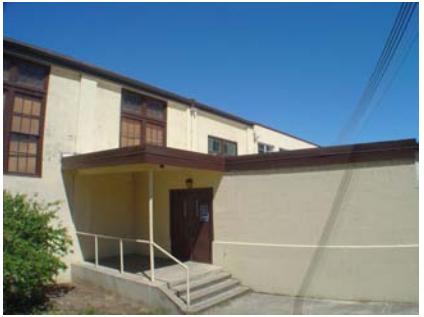
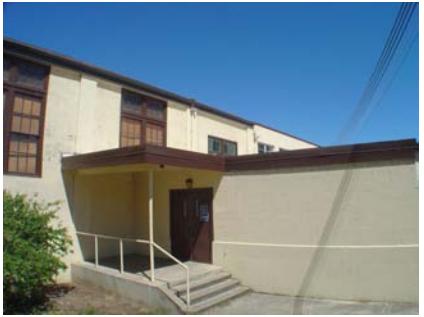
S Plan Irregularity Primary		S Vertical Irregularity Primary

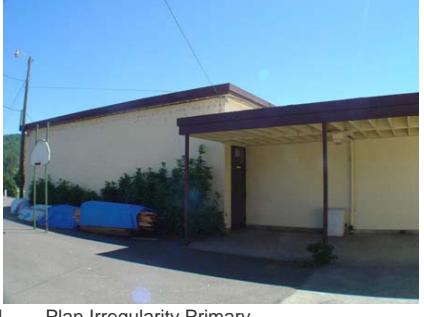
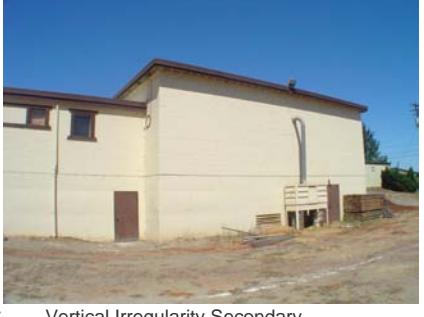
N Plan Irregularity Primary		S Vertical Irregularity Secondary

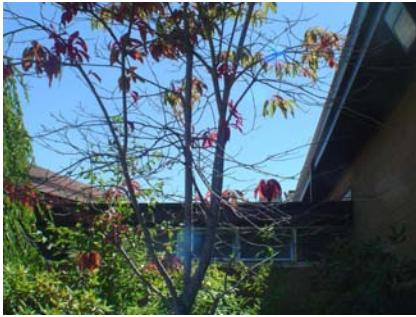
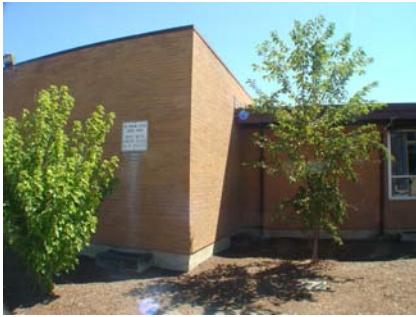
N    Vertical Irregularity Primary reentrant corner as well
