Glendale High School

Glendale SD 77

FEMA 154 Rapid Visual Screening Score Card

Rapid Visual Screening - Senate Bill #2 - Seismic Needs Assessment
Oregon Department of Geology and Mineral Industries

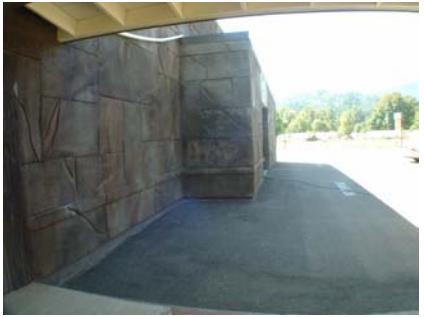
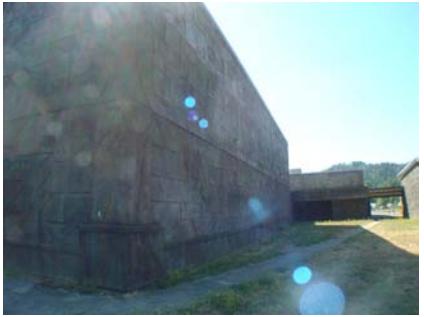
W	Plan Irregularity Secondary	NW	Plan Irregularity Primary

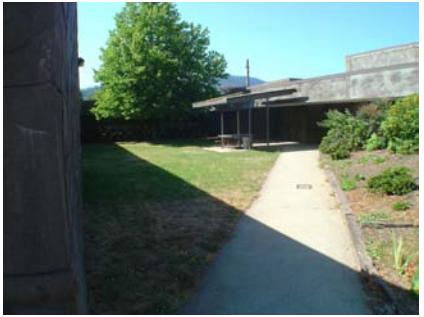
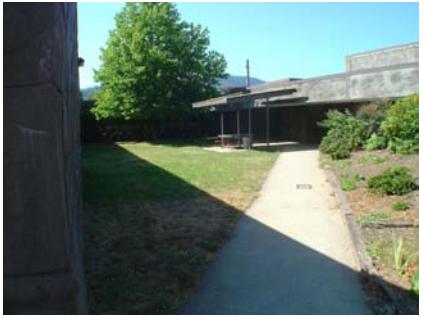
N	Plan Irregularity Primary

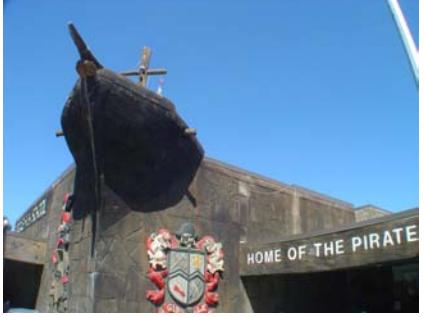
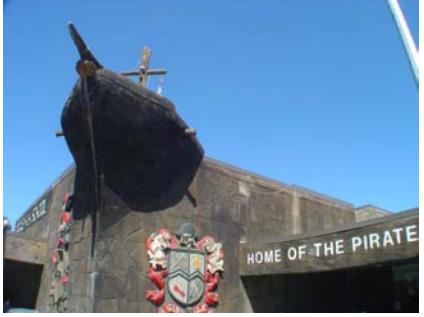
S	Falling Hazard

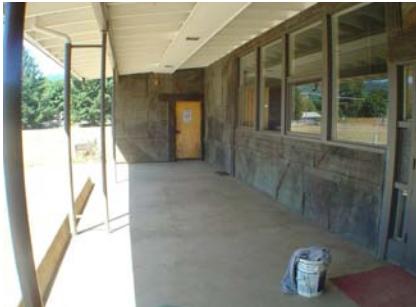
S Plan Irregularity Primary

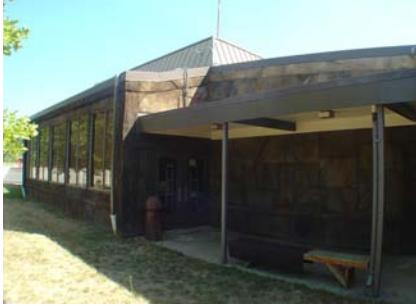
W Plan Irregularity Primary
