Highland Elementary School

Doug_sch24A

FEMA 154 Rapid Visual Screening Score Card

Rapid Visual Screening - Senate Bill #2 - Seismic Needs Assessment
Oregon Department of Geology and Mineral Industries

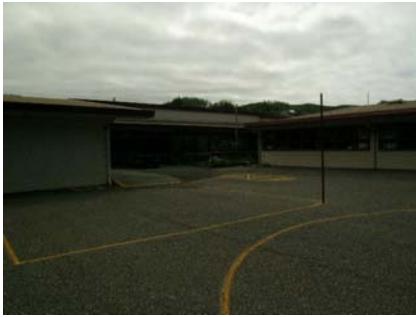
N Plan Irregularity Primary

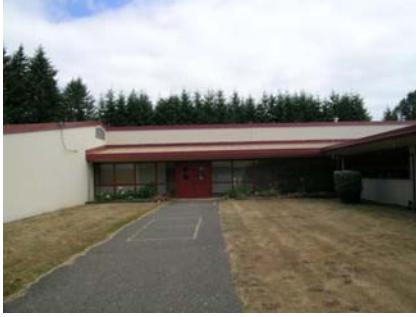
W Plan Irregularity Primary

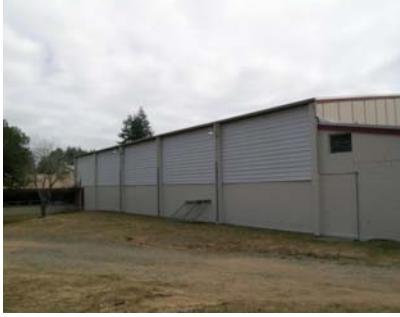
NW Tertiary Structural Type S3 on the upper portion of this building.

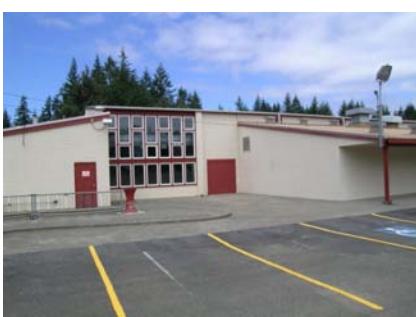
SE Plan Irregularity Primary

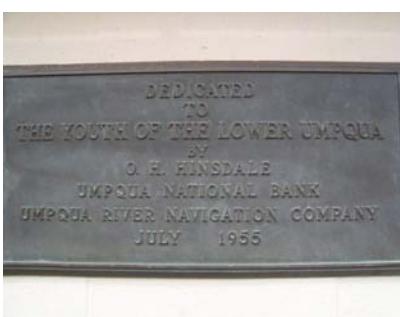
SE Field Verified Year Built

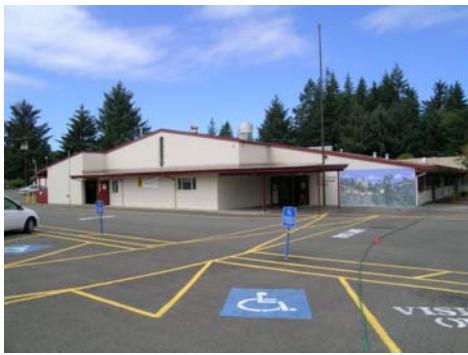
SE General Site
