# Douglas High School

Doug\_sch26A

## FEMA 154 Rapid Visual Screening Score Card

Rapid Visual Screening - Senate Bill #2 - Seismic Needs Assessment  
Oregon Department of Geology and Mineral Industries

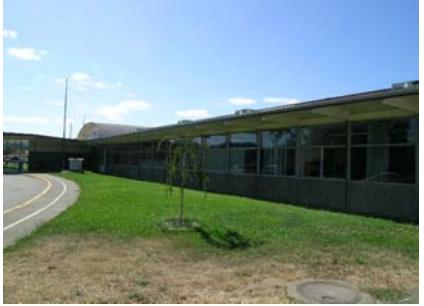
| S Elevation View | E Vertical Irregularity Secondary and reentrant corner. | | N Elevation View |

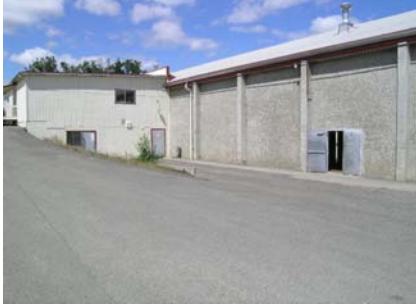
| | W Poor Condition<br>cracked concrete column. There is also evidence of concrete spalling that has been patched. | | SW Vertical Irregularity Primary<br>sloped site and reentrant corner. The top half of the left section is W2. | | N Primary Structural Type<br>and secondary structural type. |

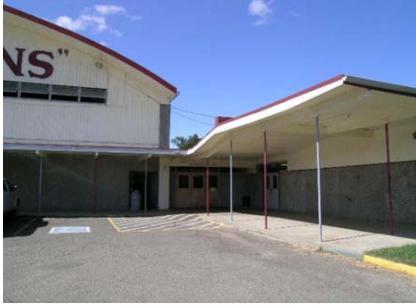
| | SW Vertical Irregularity Secondary<br>and reentrant corner due to adjacent building. Building A is on the right and building B is on the left. | | | | |

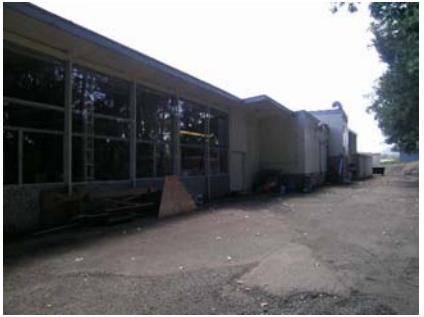
| S Primary Structural Type | | NW Plan Irregularity Tertiary out of plane LFRS | |

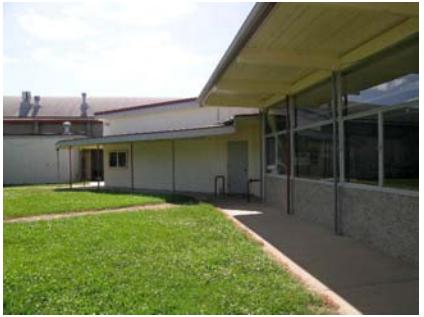
| | | SE Plan Irregularity Secondary | |

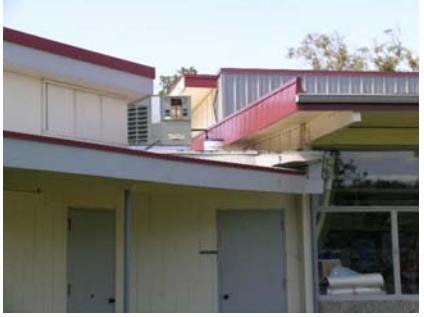
| S Vertical Irregularity Primary | | | |

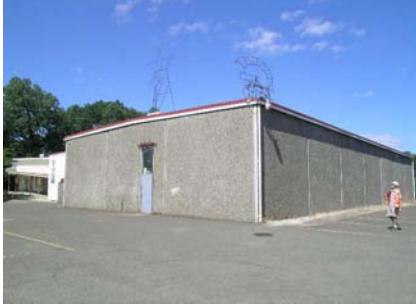
| <br>SW Elevation View | | <br>W Primary Structural Type<br>Steel embed plate between two PC1 walls. | |
