Sutherlin Middle School

Sutherlin SD 130

Doug_sch28A

Rapid Visual Screening - Senate Bill #2 - Seismic Needs Assessment
Oregon Department of Geology and Mineral Industries

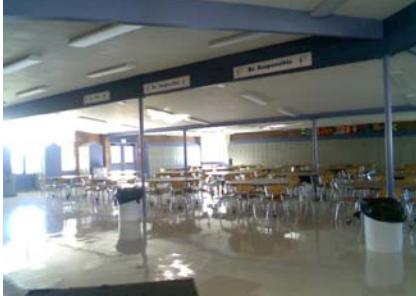
| | SE General Site | | NE Plan Irregularity Primary |

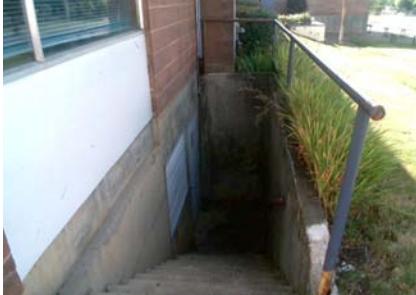
| | SW Plan Irregularity Secondary reentrant corner | | SE Vertical Irregularity Primary sloped site |

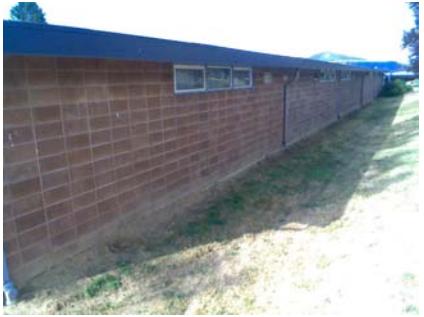
| N Plan Irregularity Primary solid back and ends, open front | | E Primary Structural Type | |

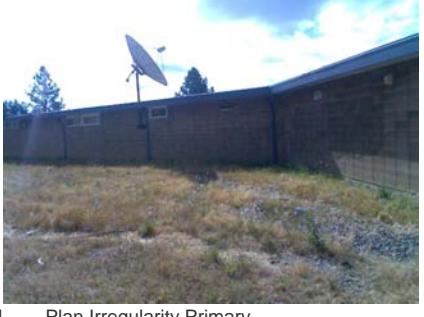
| N Plan Irregularity Primary also shows the back wall of this building is solid indicating a torsion problem. | | S General Site front of building. | |

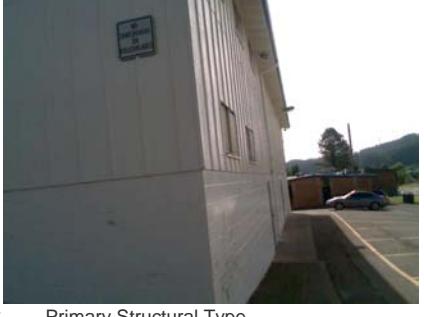
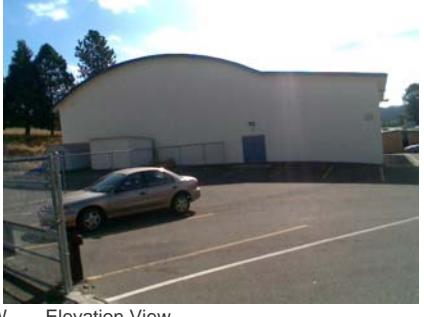
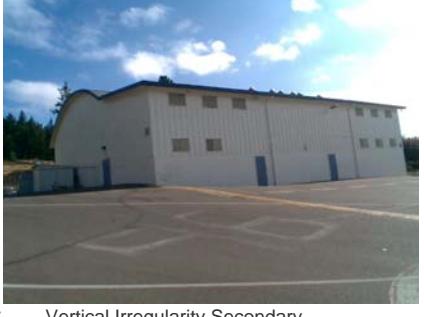
| | | | <p>S Primary Structural Type and secondary structural type</p> <p>W Elevation View</p> <p>S Vertical Irregularity Secondary sloped site (minor)</p> |
