Reedsport Junior/High School

Doug_sch33A

FEMA 154 Rapid Visual Screening Score Card

Rapid Visual Screening - Senate Bill #2 - Seismic Needs Assessment
Oregon Department of Geology and Mineral Industries

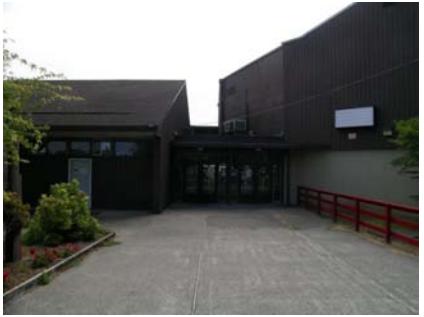
NE Vertical Irregularity Secondary and secondary plan irregularity building A is on the left and building B is on the right.	NW Elevation View	NW Plan Irregularity Primary

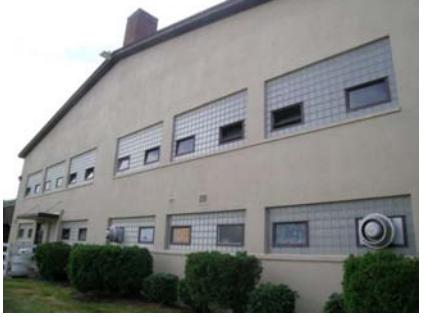
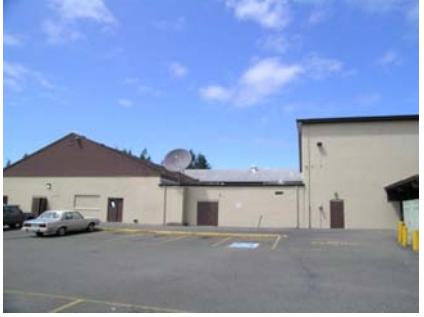
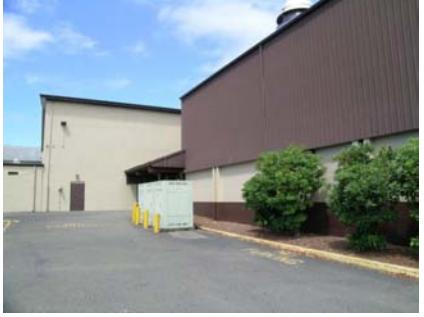
NW Elevation View	SW Vertical Irregularity Primary	SE Plan Irregularity Secondary reentrant corner due to adjacent building. Building A is on the left and building C is on the right.

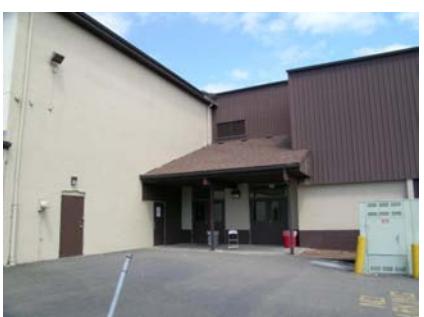
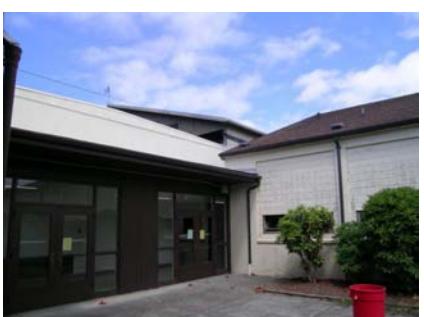
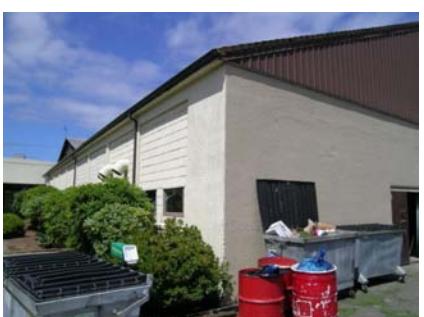
SE Plan Irregularity Secondary due to adjacent building. Building A is on the left and building C is on the right.	SE Plan Irregularity Primary	SE Elevation View

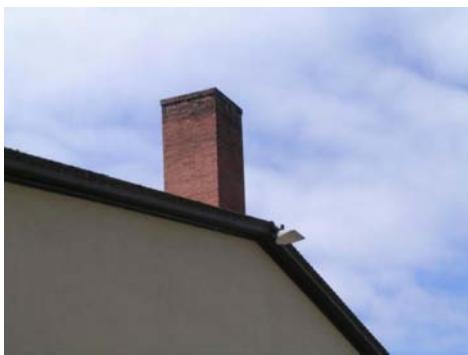
NE Falling Hazard
reinforced?

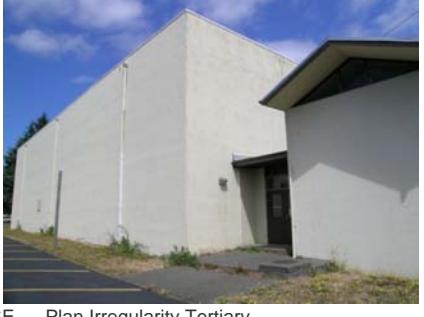
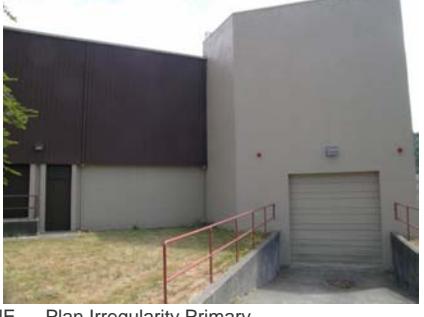
SE Plan Irregularity Tertiary		NE Plan Irregularity Primary

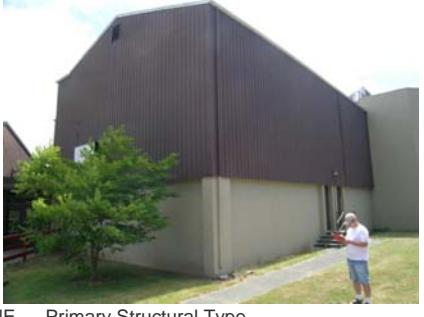
NE Primary Structural Type and secondary structural type

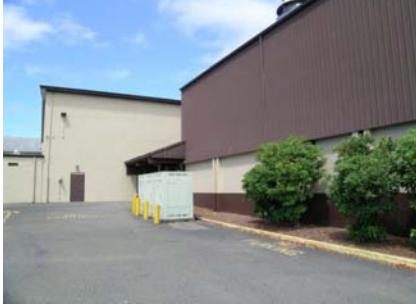
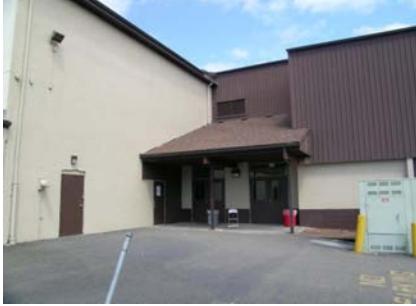
SE Plan Irregularity Primary		SE Plan Irregularity Primary

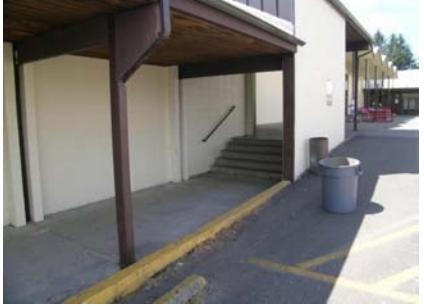
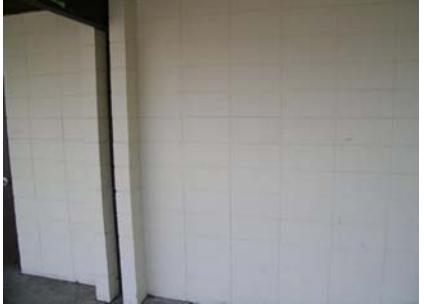
NE Vertical Irregularity Primary		NE Primary Structural Type

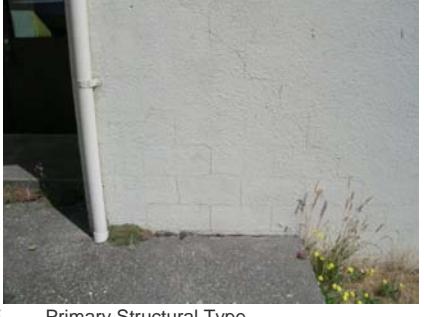
E Primary Structural Type

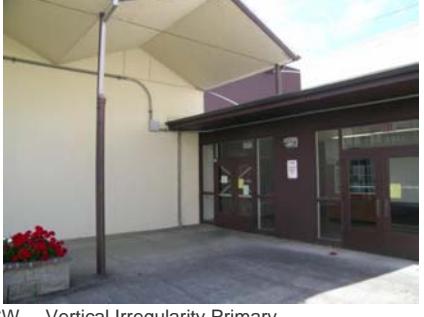
SW Vertical Irregularity Primary and reentrant corner
