# Melrose Elementary School

Douglas County SD 4

Doug\_sch34A

Rapid Visual Screening - Senate Bill #2 - Seismic Needs Assessment  
Oregon Department of Geology and Mineral Industries

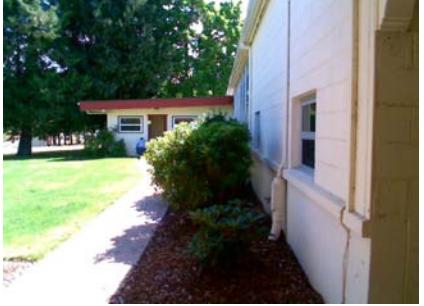
Enrollment 272	Year Built (Field Verified) 1929	Year Built (Alt. Source) 1929	Est. Decade Built 1960
Total Area (square ft) 29567	Number of Stories 1	Basement	Pounding Potential No
Plan Irregularities Reentrant Corners: Other None None		Vertical Irregularities Steps in Elevation View: 2 to 3 Changes None None	
Falling Hazards Unreinforced Chimneys None None		Poor Conditions None None None

NW Vertical Irregularity Primary		S Falling Hazard

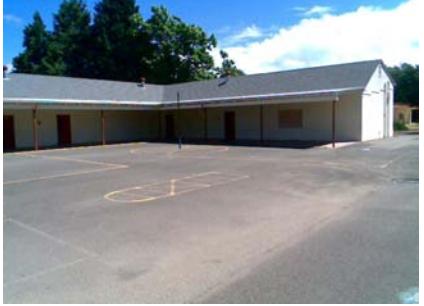
SW Plan Irregularity Primary

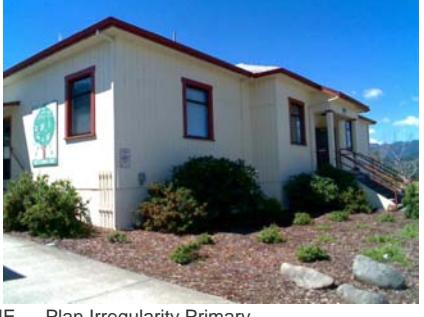
Enrollment 272	Year Built (Field Verified) 1929	Year Built (Alt. Source) 1929	Est. Decade Built 1920
Total Area (square ft) 29567	Number of Stories 1	Basement	Pounding Potential No
Plan Irregularities Out of Plane Lateral-Force-Resistance Elements None None		Vertical Irregularities None None None	
Falling Hazards None None None		Poor Conditions None None None

NE Plan Irregularity Primary

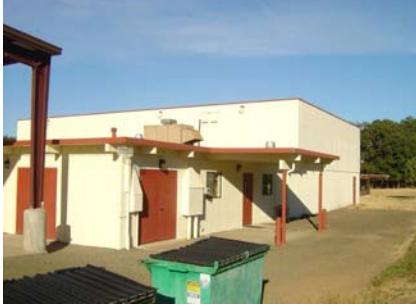
Enrollment 272	Year Built (Field Verified) 1929	Year Built (Alt. Source) 1960	Est. Decade Built 1960
Total Area (square ft) 29567	Number of Stories 1	Basement	Pounding Potential No
Plan Irregularities Reentrant Corners: Other None None		Vertical Irregularities Steps in Elevation View: 2 to 3 Changes None None	
Falling Hazards None None None		Poor Conditions None None None

SW Vertical Irregularity Primary

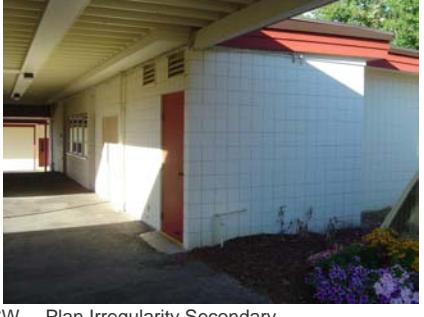
Enrollment 272	Year Built (Field Verified) 1929	Year Built (Alt. Source) 1929	Est. Decade Built 1960
Total Area (square ft) 29567	Number of Stories 1	Basement	Pounding Potential No
Plan Irregularities		Vertical Irregularities	
Reentrant Corners: L Shaped		None	
Out of Plane Lateral-Force-Resistance Elements		None	
None		None	
Falling Hazards		Poor Conditions	
None		None	
None		None	
None		None

SW Plan Irregularity Secondary
