McGovern Elementary School

Doug_sch35A

FEMA 154 Rapid Visual Screening Score Card

Rapid Visual Screening - Senate Bill #2 - Seismic Needs Assessment
Oregon Department of Geology and Mineral Industries

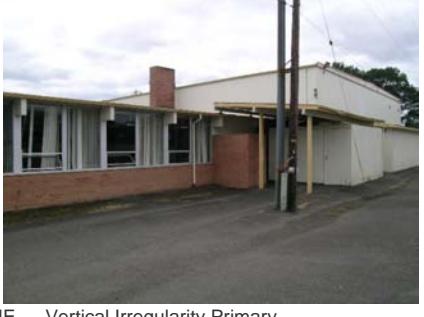
<p>NE Vertical Irregularity Primary and reentrant corner</p> <p>E General Site</p> <p>S Vertical Irregularity Primary</p>

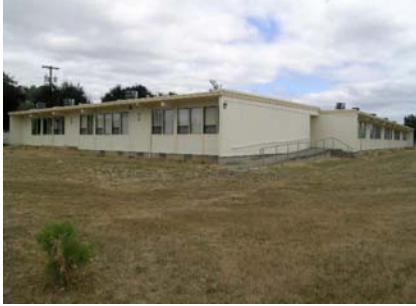
SW Plan Irregularity Primary
