Lookingglass Elementary School

Winston-Dillard SD 116

Doug_sch38A

FEMA 154 Rapid Visual Screening Score Card

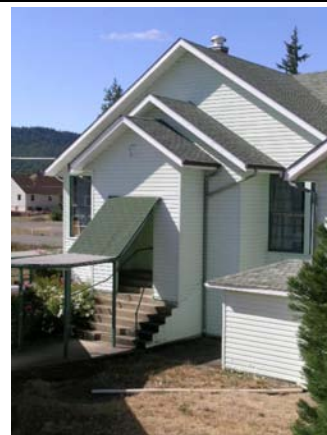
Type	Basic Score	Vert Irreg	Plan Irreg	Pre-Code	Post-Bench	Soil C	Soil D	Soil E	RVS Score
Primary	W2	3.8	-2	-0.5	-1	0	-0.4	0	0	-0.1
Secondary		0	0	0	0	0	0	0	0	0
Tertiary		0	0	0	0	0	0	0	0	0

-0.1

Very High (100%)

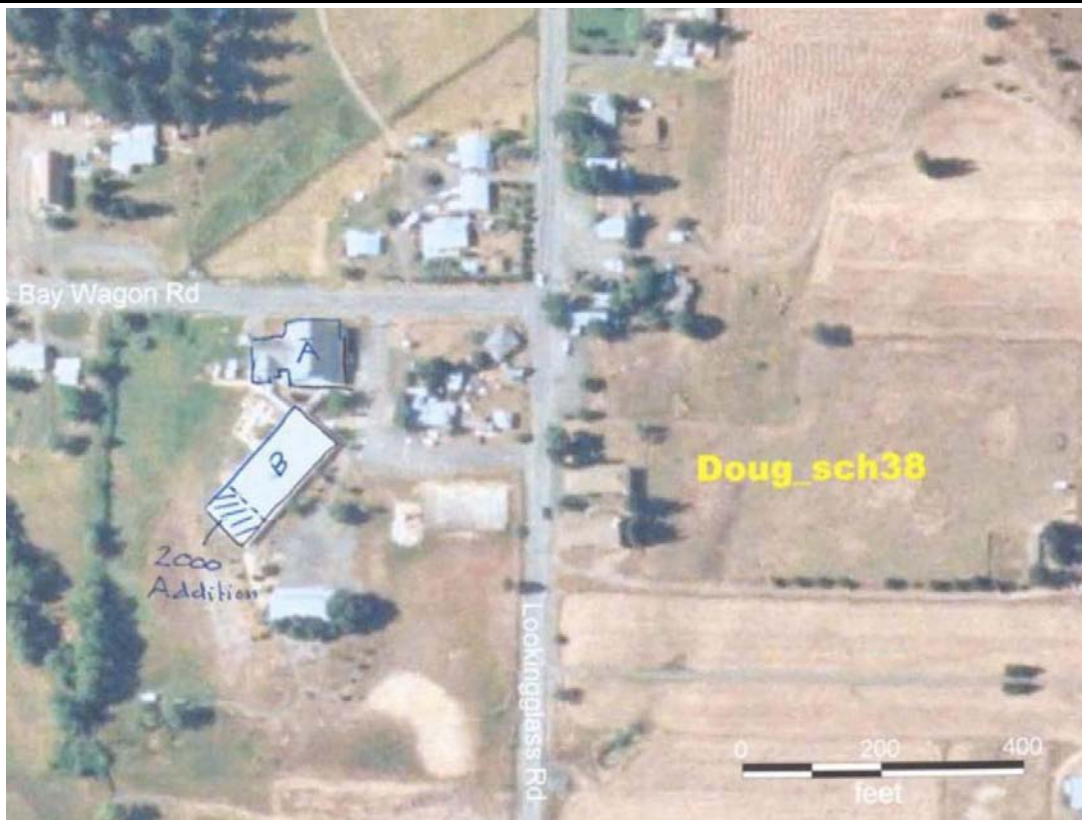
NW Plan Irregularity Primary and also elevation step

N Poor Condition

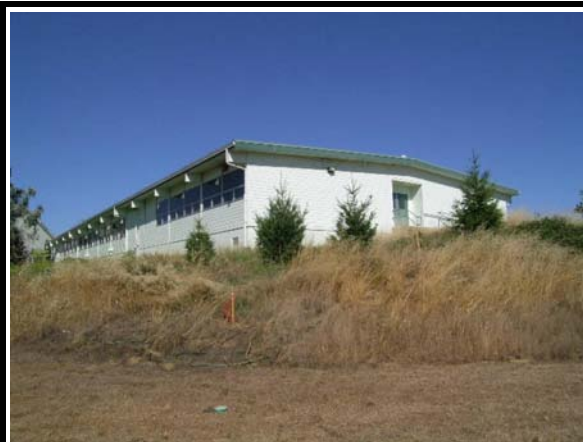
Type	Basic Score	Vert Irreg	Plan Irreg	Pre-Code	Post-Bench	Soil C	Soil D	Soil E	RVS Score
Primary	W2	3.8	0	0	0	0	-0.4	0	0	3.4
Secondary		0	0	0	0	0	0	0	0	0
Tertiary		0	0	0	0	0	0	0	0	0

3.4

Low (<1%)
