Camas Valley School

Camas Valley SD 21J

FEMA 154 Rapid Visual Screening Score Card

Rapid Visual Screening - Senate Bill #2 - Seismic Needs Assessment
Oregon Department of Geology and Mineral Industries

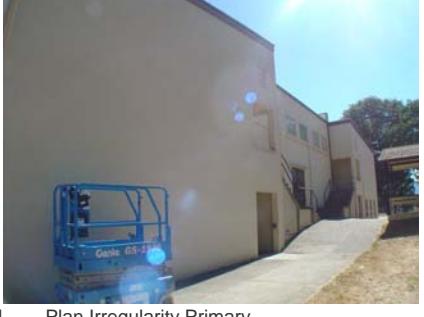
Enrollment 162	Year Built (Field Verified) 1928	Year Built (Alt. Source) 1928	Est. Decade Built 1920
Total Area (square ft) 39030	Number of Stories 2	Basement	Pounding Potential No
Plan Irregularities Out of Plane Lateral-Force-Resistance Elements None None		Vertical Irregularities None None None	
Falling Hazards None None None		Poor Conditions None None None

N Plan Irregularity Primary

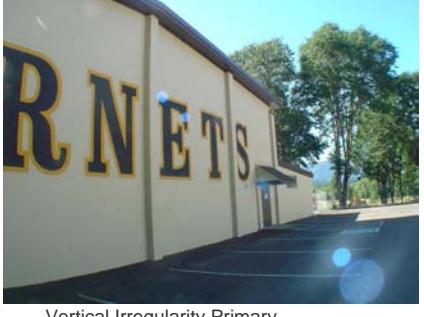
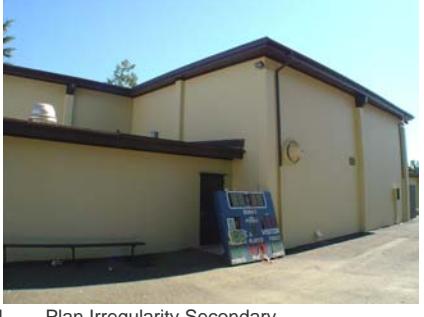
Enrollment 162	Year Built (Field Verified) 1970	Year Built (Alt. Source) 1928	Est. Decade Built 1970
Total Area (square ft) 39030	Number of Stories 1	Basement	Pounding Potential No
Plan Irregularities		Vertical Irregularities	
Reentrant Corners: Other		Steps in Elevation View: 2 to 3 Changes	
Out of Plane Lateral-Force-Resistance Elements		None	
None		None	
Falling Hazards		Poor Conditions	
None		None	
None		None	
None		None

E Vertical Irregularity Primary		N Plan Irregularity Secondary

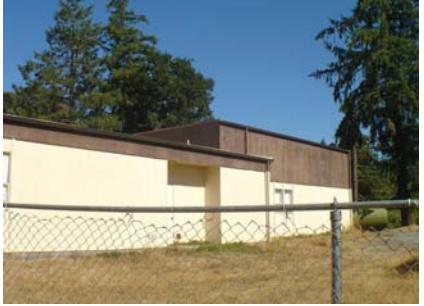
Enrollment 162	Year Built (Field Verified) 1978	Year Built (Alt. Source) 1928	Est. Decade Built 1970
Total Area (square ft) 39030	Number of Stories 1	Basement	Pounding Potential No
Plan Irregularities Out of Plane Lateral-Force-Resistance Elements None None		Vertical Irregularities Steps in Elevation View: Single Change None None	
Falling Hazards None None None		Poor Conditions None None None

W Vertical Irregularity Primary
