City Of Condon VFD/PD

Gill_fir01A

Building Type	County
Fire - City	Gilliam
Street	
128 S Main St	
City	State Zip
Condon	OR 97823
Latitude	Longitude
45.23646	120.18447
Tracking Code	Inspection Date
RVS in 2006	8/29/2006

Rapid Visual Screening - Senate Bill #2 - Seismic Needs Assessment
Oregon Department of Geology and Mineral Industries

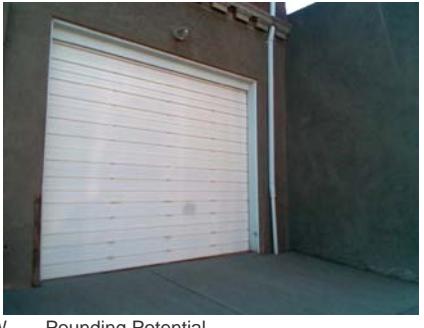
W Pounding Potential

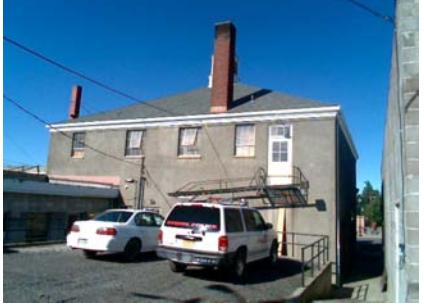
NE Elevation View		NE Falling Hazard

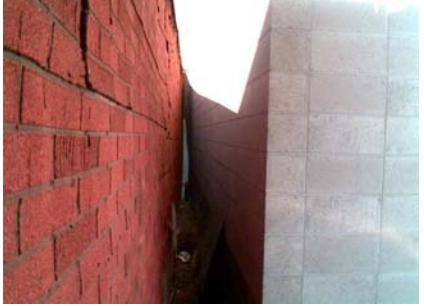
NE Elevation View		SE Elevation View B ONLY CONNECTS TO A
