Gilliam County

## FEMA 154 Rapid Visual Screening Score Card

Gilliam County Sheriff's Office

Rapid Visual Screening - Senate Bill #2 - Seismic Needs Assessment  
Oregon Department of Geology and Mineral Industries

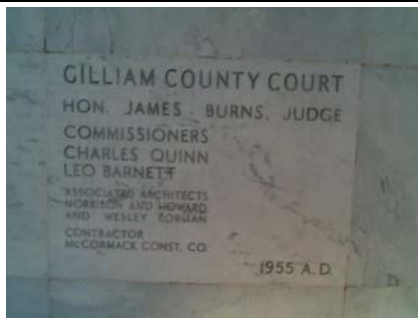
E Field Verified Year Built

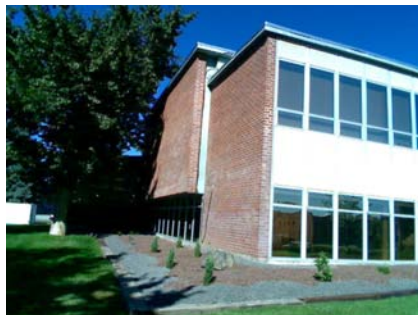
SE Plan Irregularity Secondary

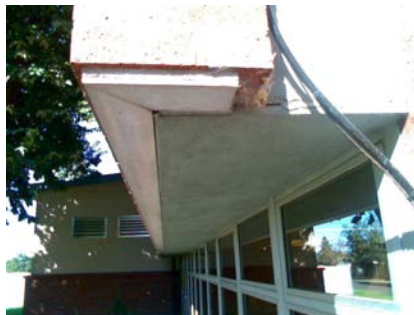
SE Other  
CONC BUMP-OUT

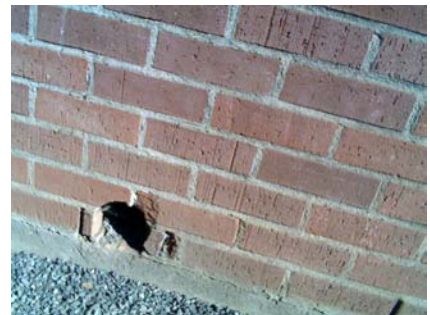
S Secondary Structural Type  
2ND WYTHER OF BRICKS IN HOLE AND A ~2" GROUTED CAVITY

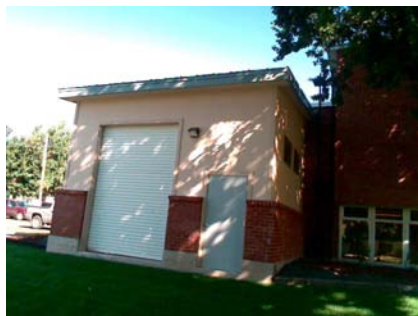
S Vertical Irregularity Primary

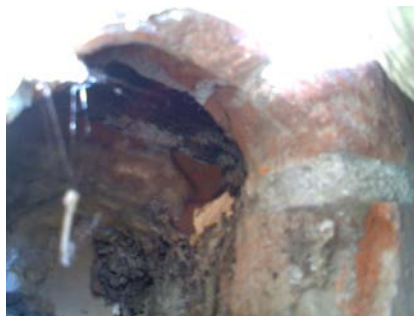
S Secondary Structural Type  
PIC OF HOLE IN BRICK

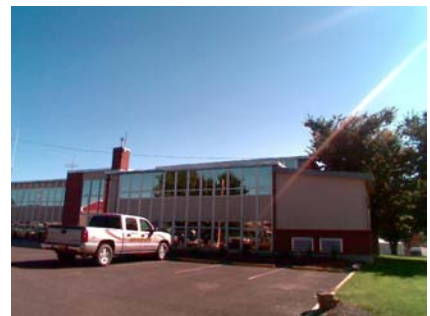
SW Vertical Irregularity Primary

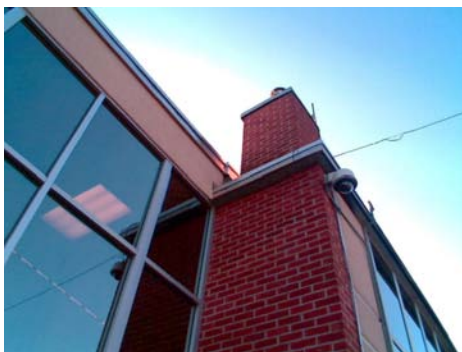
| Other: Brick Veneer | None |

W Falling Hazard
