# Condon High School

Gill\_sch01A

## FEMA 154 Rapid Visual Screening Score Card

Rapid Visual Screening - Senate Bill #2 - Seismic Needs Assessment  
Oregon Department of Geology and Mineral Industries

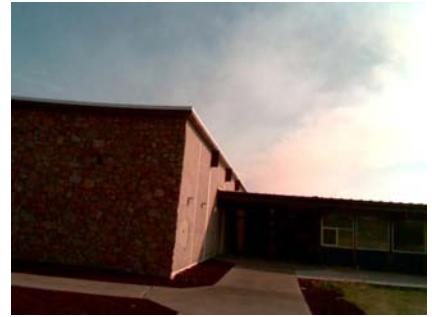
NW Plan Irregularity Primary

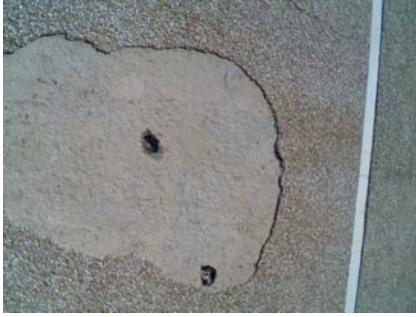
W Primary Structural Type

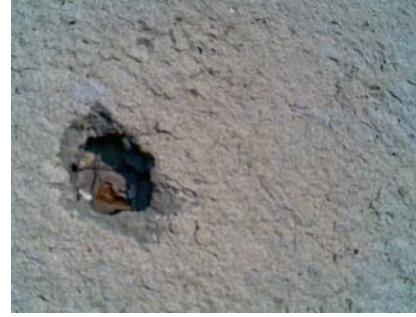
W Primary Structural Type  
WOOD SIDING BENEATH STUCCO

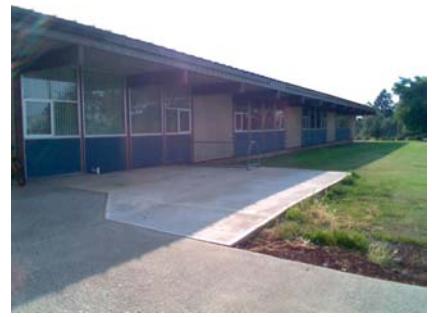
N Elevation View  
W WING

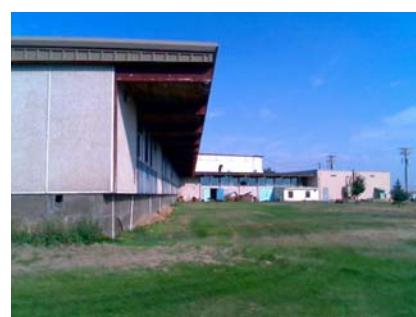
W Vertical Irregularity Secondary

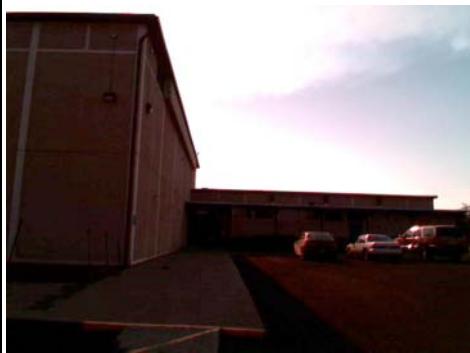
E Plan Irregularity Primary

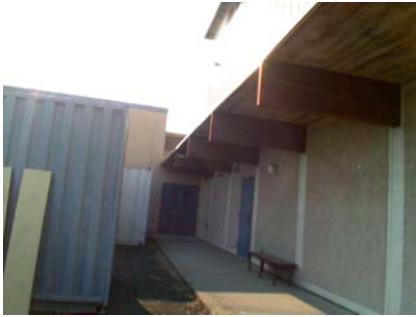
E General Site CONN TO A

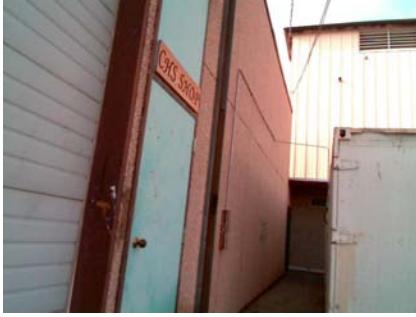
SE General Site CONN TO A
