Condon Elementary School

Gill_sch04A

FEMA 154 Rapid Visual Screening Score Card

Rapid Visual Screening - Senate Bill #2 - Seismic Needs Assessment
Oregon Department of Geology and Mineral Industries

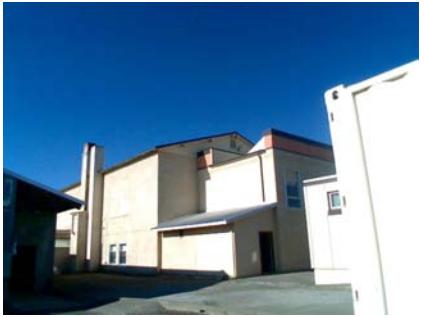
SW General Site CONN TO B		NE Falling Hazard

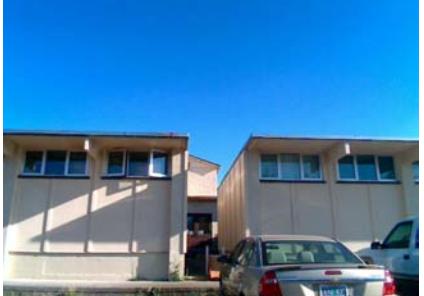
W Plan Irregularity Primary		E Elevation View

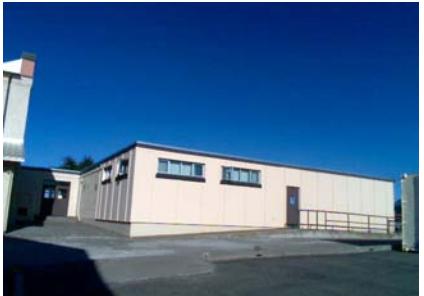
SE Elevation View		E Plan Irregularity Primary

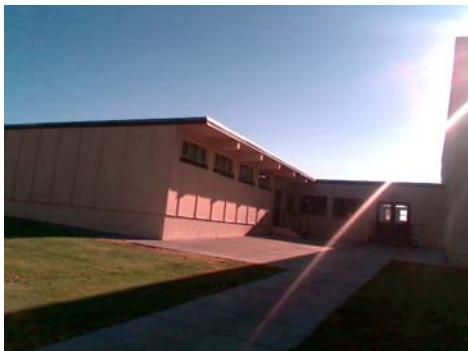
SW Plan Irregularity Primary

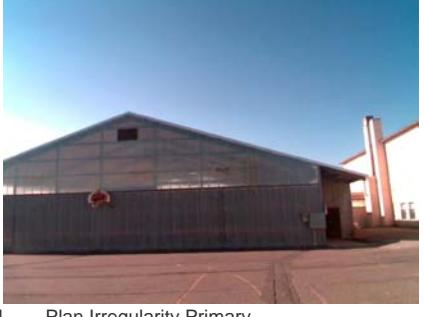
N Plan Irregularity Primary
