# John Day Fire Department

Gran\_fir05A

Rapid Visual Screening - Senate Bill #2 - Seismic Needs Assessment  
Oregon Department of Geology and Mineral Industries

Gran\_fir05B

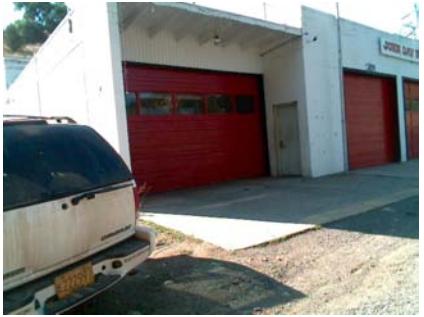
NW Plan Irregularity Primary		NW Vertical Irregularity Tertiary

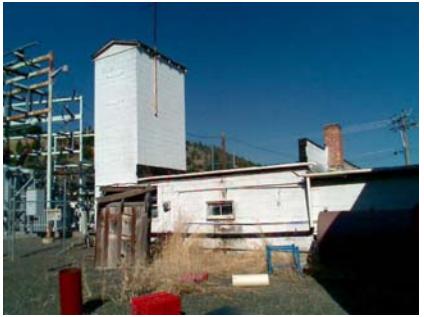
SW Vertical Irregularity Primary

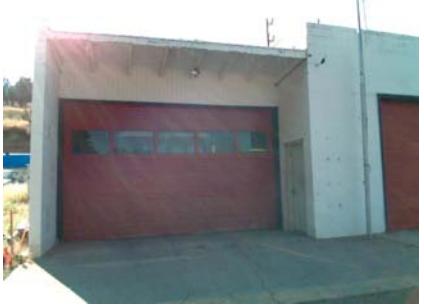
NW Plan Irregularity Secondary		N Vertical Irregularity Primary
