Dayville School

Gran_sch03A

Building Type School	County Grant	
Street 285 School House Dr		
City Dayville	State OR	Zip 97825
Latitude 44.4675	Longitude 119.53773	
Tracking Code RVS in 2006	Inspection Date 7/26/2006

Rapid Visual Screening - Senate Bill #2 - Seismic Needs Assessment
Oregon Department of Geology and Mineral Industries

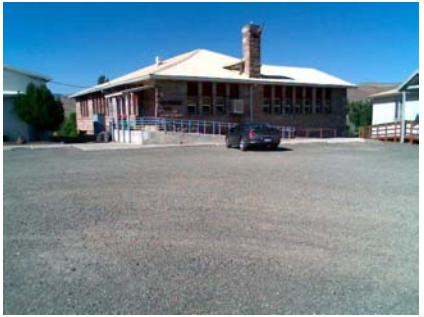
S Elevation View	E Field Verified Year Built	SW Elevation View

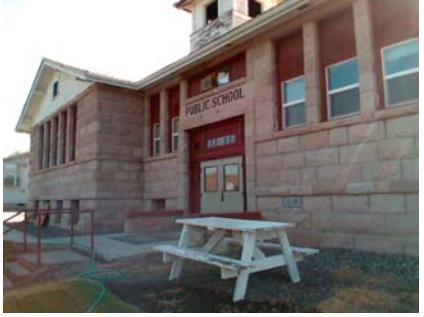
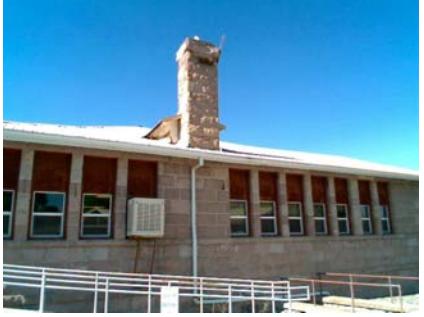
Enrollment 58	Year Built (Field Verified) 1924	Year Built (Alt. Source) 1924	Est. Decade Built 1920
Total Area (square ft) 5825	Number of Stories 1	Basement	Pounding Potential No
Plan Irregularities Reentrant Corners: L Shaped None None		Vertical Irregularities None None None	
Falling Hazards Unreinforced Chimneys None None		Poor Conditions None None None

NE Plan Irregularity Primary	S Falling Hazard

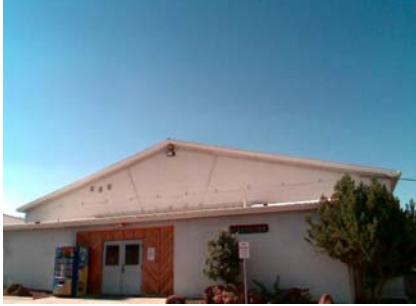
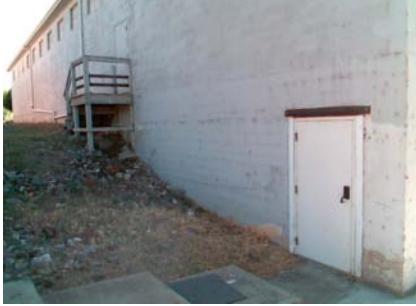
Enrollment 58	Year Built (Field Verified) 1924	Year Built (Alt. Source) 1950	Est. Decade Built
Total Area (square ft) 5825	Number of Stories 1	Basement	Pounding Potential No
Plan Irregularities None None None		Vertical Irregularities Steps in Elevation View: Single Change Building On Hill or Sloped Site None	
Falling Hazards None None None		Poor Conditions None None None

S Vertical Irregularity Primary		E Vertical Irregularity Secondary

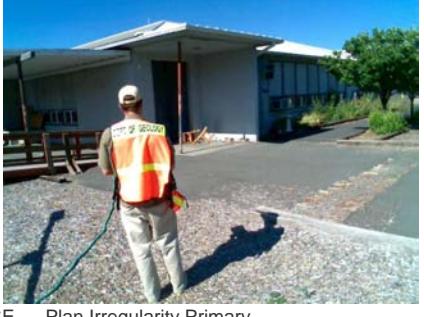
Enrollment 58	Year Built (Field Verified) 1924	Year Built (Alt. Source) 1924	Est. Decade Built 1960
Total Area (square ft) 5825	Number of Stories 1	Basement	Pounding Potential No
Plan Irregularities Reentrant Corners: Other None None		Vertical Irregularities None None None	
Falling Hazards None None None		Poor Conditions None None None

SE Plan Irregularity Primary
