Grant Union High School

Gran_sch05A

FEMA 154 Rapid Visual Screening Score Card

Rapid Visual Screening - Senate Bill #2 - Seismic Needs Assessment
Oregon Department of Geology and Mineral Industries

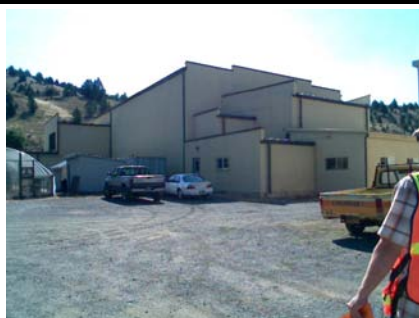
Plan Irregularities	Vertical Irregularities
Reentrant Corners: T shaped	Steps in Elevation View: Very Irregular Changes
Reentrant Corners: Other	Steps in Elevation View: Single Change (Adjacent Building/Entity)
None	Internal Discontinuous Diaphragm (large internal opening)

W Vertical Irregularity Primary

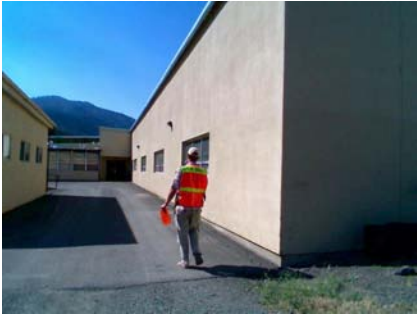
Plan Irregularities	Vertical Irregularities
Reentrant Corners:L shaped (Adjacent Build/Entity)	None
None	None
None	None

E Plan Irregularity Primary

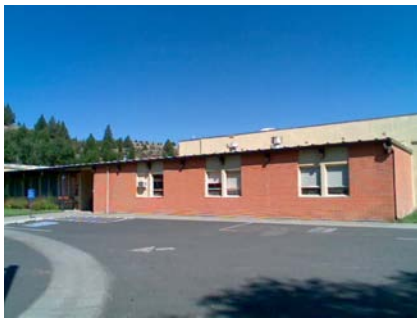
Plan Irregularities	Vertical Irregularities
Reentrant Corners: Other (Adjacent Build/Entity)	Steps in Elevation View: 2 to 3 Changes (Adjacent Building/Entity)
Reentrant Corners: L Shaped	None
None	None

S Elevation View

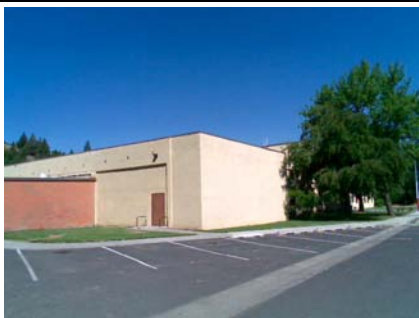
Plan Irregularities	Vertical Irregularities
Reentrant Corners: Other (Adjacent Build/Entity)	Steps in Elevation View: 2 to 3 Changes (Adjacent Building/Entity)
None	None
None	None

SE Vertical Irregularity Primary

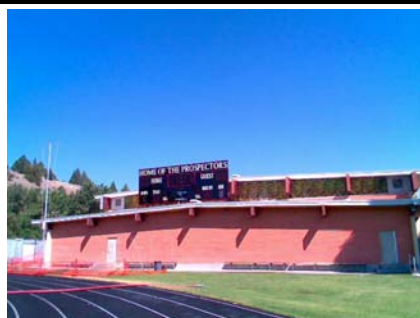
Plan Irregularities	Vertical Irregularities
Out of Plane Lateral-Force-Resistance Elements	Steps in Elevation View: Single Change
Reentrant Corners: Other	Steps in Elevation View: Single Change (Adjacent Building/Entity)
None	None

S Vertical Irregularity Primary

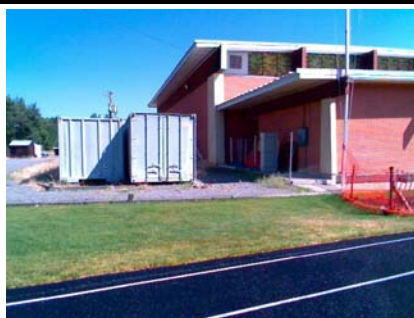
SW Plan Irregularity Primary

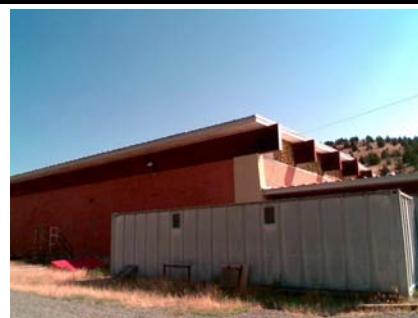
SW Vertical Irregularity Primary
