# Seneca Elementary School

John Day SD 3

Gran\_sch07A

Rapid Visual Screening - Senate Bill #2 - Seismic Needs Assessment  
Oregon Department of Geology and Mineral Industries

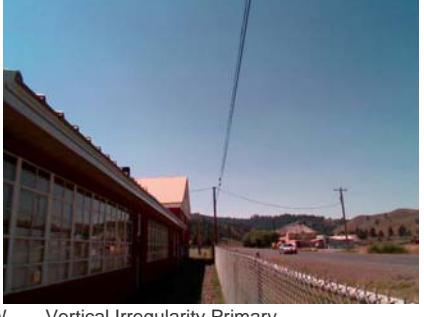
W    Vertical Irregularity Primary

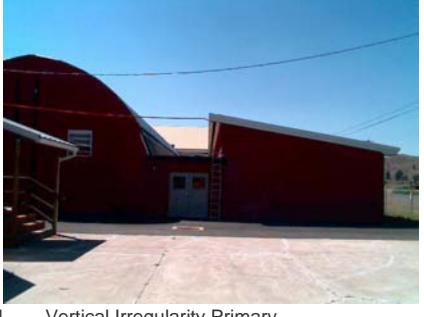
N    Vertical Irregularity Primary

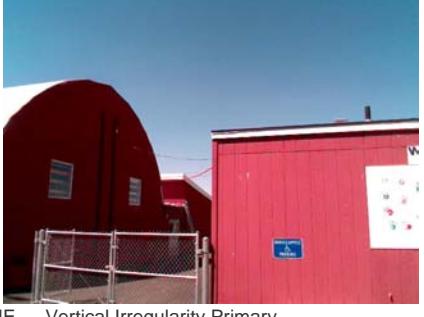
NE Vertical Irregularity Primary

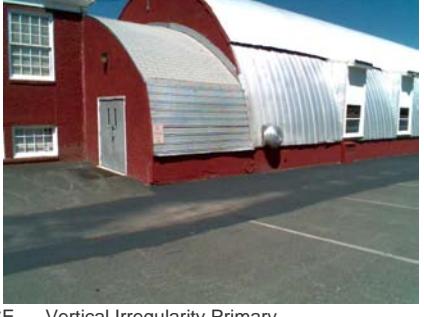
SE Vertical Irregularity Primary

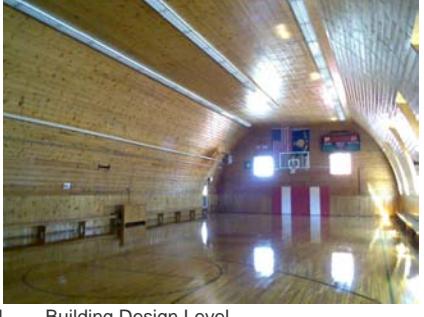
N Building Design Level
