Crane Union High School

Harn_sch01A

FEMA 154 Rapid Visual Screening Score Card

Rapid Visual Screening - Senate Bill #2 - Seismic Needs Assessment
Oregon Department of Geology and Mineral Industries

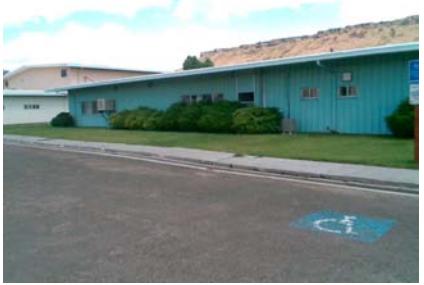
S Elevation View

Enrollment 84	Year Built (Field Verified) 1972	Year Built (Alt. Source) 1950	Est. Decade Built 1970
Total Area (square ft) 38432	Number of Stories 1	Basement	Pounding Potential No
Plan Irregularities None None None		Vertical Irregularities None None None	
Falling Hazards None None None		Poor Conditions None None None

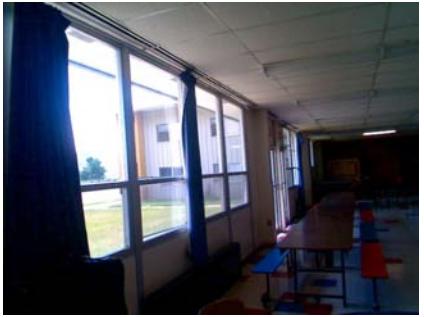
E Primary Structural Type

Enrollment 84	Year Built (Field Verified) 1972	Year Built (Alt. Source) 1950	Est. Decade Built 1970
Total Area (square ft) 38432	Number of Stories 2	Basement	Pounding Potential No
Plan Irregularities Reentrant Corners: T shaped None None		Vertical Irregularities Steps in Elevation View: Single Change None None	
Falling Hazards None None None		Poor Conditions None None None
