Hood River FD

| 1785 Meyer Parkway | | |

FEMA 154 Rapid Visual Screening Score Card

Rapid Visual Screening - Senate Bill #2 - Seismic Needs Assessment
Oregon Department of Geology and Mineral Industries

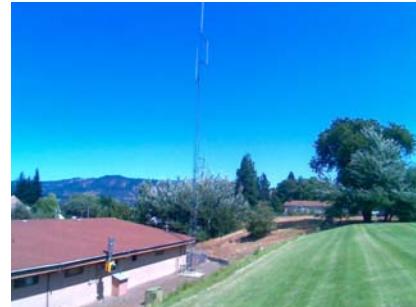
| Other: General | | None | |
| S | Elevation View | S | Falling Hazard |
