# Riverside - Building B

Rogue CC

## FEMA 154 Rapid Visual Screening Score Card

Rapid Visual Screening - Senate Bill #2 - Seismic Needs Assessment  
Oregon Department of Geology and Mineral Industries

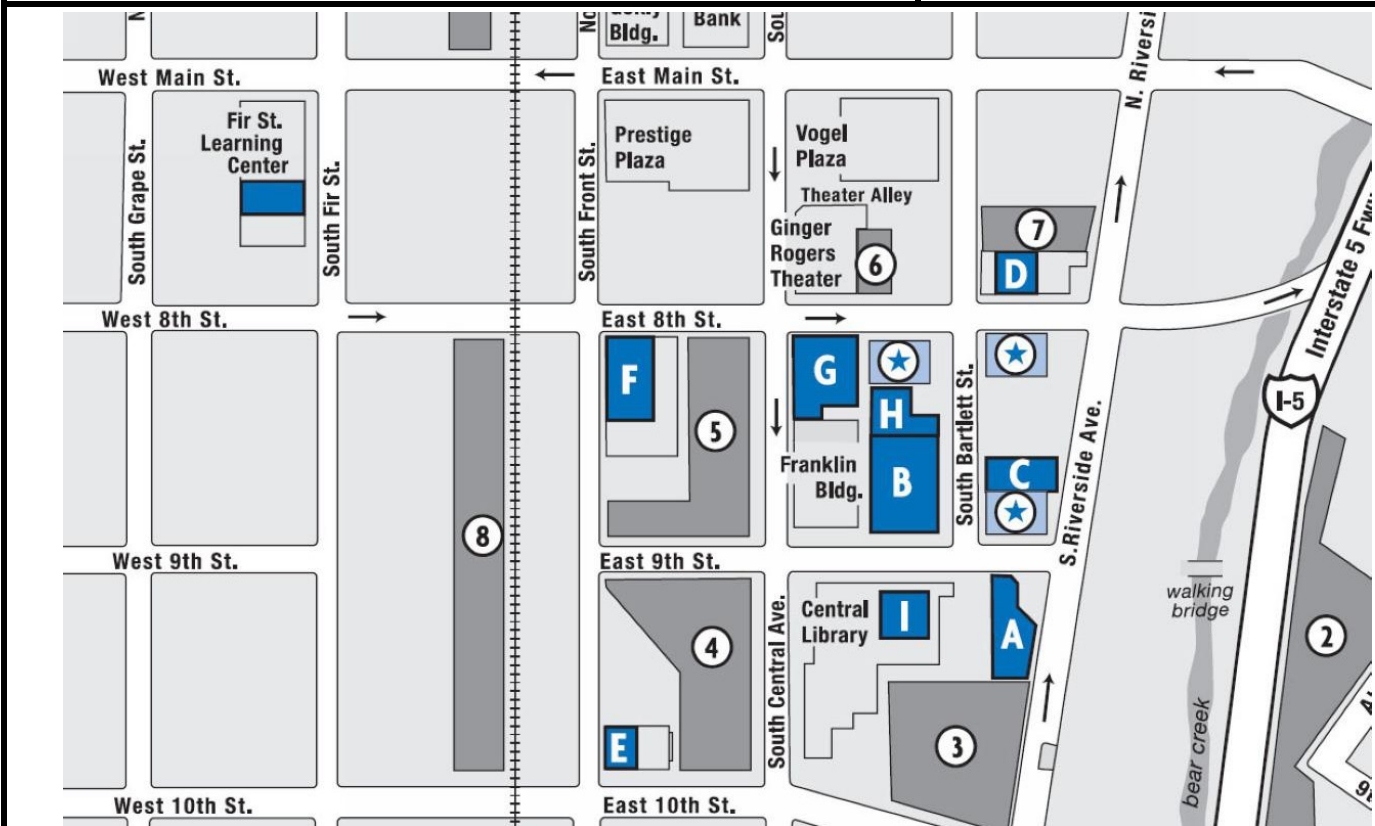
FEMA-154 Collapse Potential

Very High (100%)

| Other: Ornamental Hazard Over Exit | |
| Parapets: General | |
