Southern Oregon Regional Communications Center

Jack_eoc02A

FEMA 154 Rapid Visual Screening Score Card

Rapid Visual Screening - Senate Bill #2 - Seismic Needs Assessment
Oregon Department of Geology and Mineral Industries

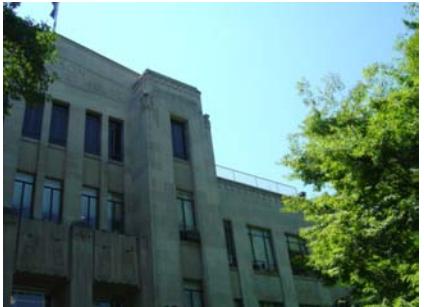
SE Elevation View		E Vertical Irregularity Primary

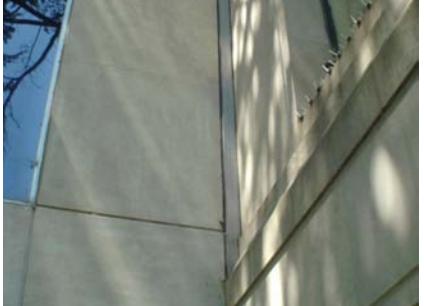
S Other Joint to newer addition.		W Plan Irregularity Primary Plan Irregularity to the new addition can be seen to the right of the picture.	
E Falling Hazard
