Rogue Valley International-Medford

Jack_fir18A

FEMA 154 Rapid Visual Screening Score Card

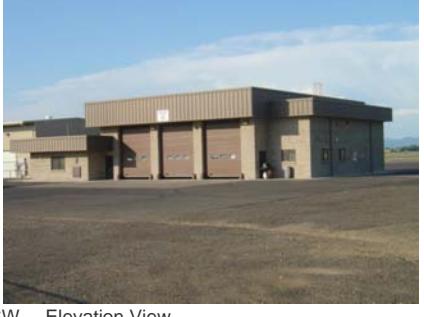
SW Elevation View also shows vertical irregularity, reentrant corner, and out of plane lateral system.		N Poor Condition There is a crack going from the bottom to the top cutting through the masonry.

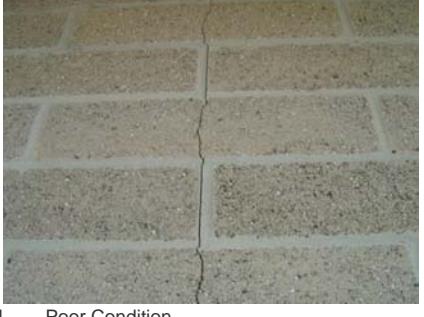
N Poor Condition
