# Medford Fire Dept Station 3

## FEMA 154 Rapid Visual Screening Score Card

Rapid Visual Screening - Senate Bill #2 - Seismic Needs Assessment  
Oregon Department of Geology and Mineral Industries

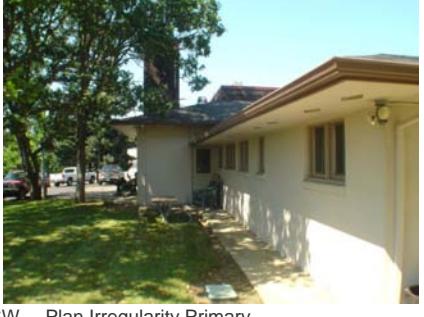
SW Plan Irregularity Primary Also shows vertical irregularity.		SE General Site

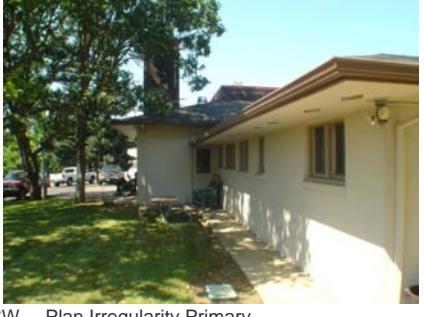
SW Plan Irregularity Primary
