# Medford Fire Dept Station 5

## FEMA 154 Rapid Visual Screening Score Card

Rapid Visual Screening - Senate Bill #2 - Seismic Needs Assessment  
Oregon Department of Geology and Mineral Industries

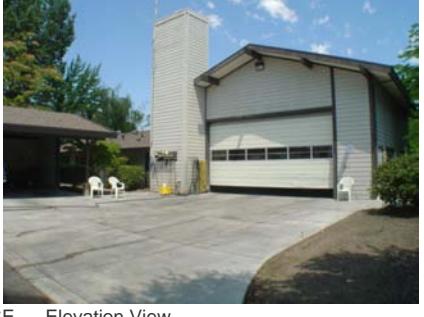
| SE Elevation View | | NW Falling Hazard | |

| Vertical irregularity due to the hose tower. | | | |

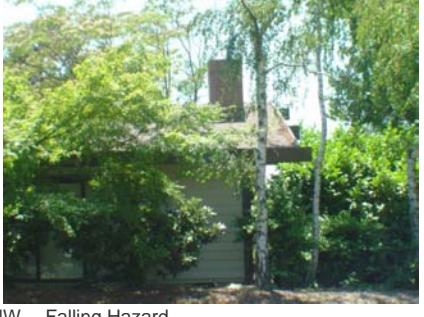
| Unreinforced Chimneys | | None | |
