Ashland Community Hospital

Jack_hos01A

FEMA 154 Rapid Visual Screening Score Card

Rapid Visual Screening - Senate Bill #2 - Seismic Needs Assessment
Oregon Department of Geology and Mineral Industries

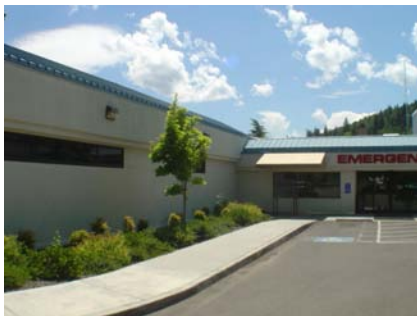
N Plan Irregularity Primary
Reentrant corner.

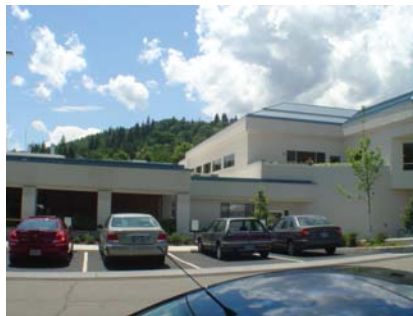
N Vertical Irregularity Primary
Vertical Irregularity due to new building.

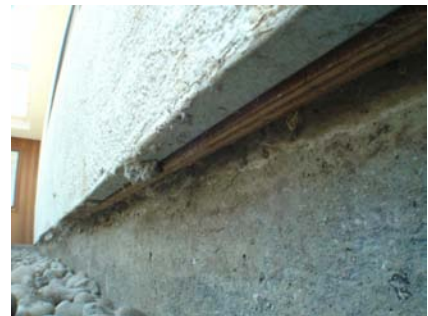
N Primary Structural Type
Can see that this is a wood structure.

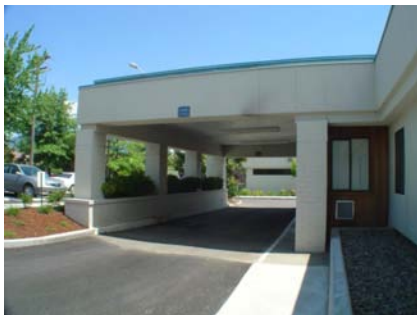
W Falling Hazard

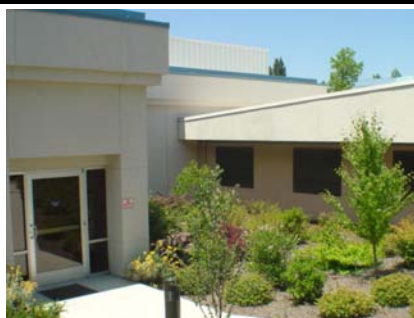
E Vertical Irregularity Primary

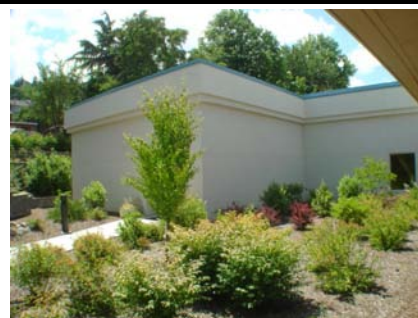
NE Plan Irregularity Primary

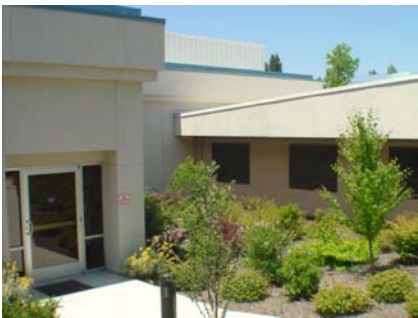
S Vertical Irregularity Primary
