Providence Medford Medical Center

Providence Health System - Oregon NFP

FEMA 154 Rapid Visual Screening Score Card

Rapid Visual Screening - Senate Bill #2 - Seismic Needs Assessment
Oregon Department of Geology and Mineral Industries

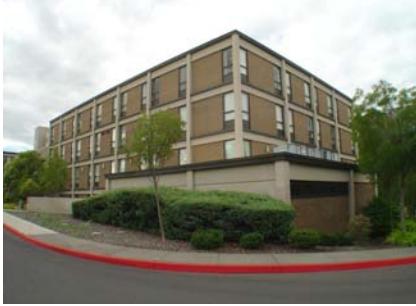
NW Elevation View		SW Vertical Irregularity Primary

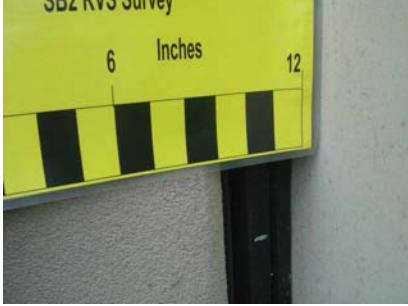
NE Pounding Potential

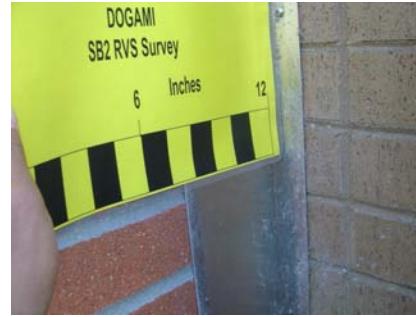
SE Elevation View		E Pounding Potential

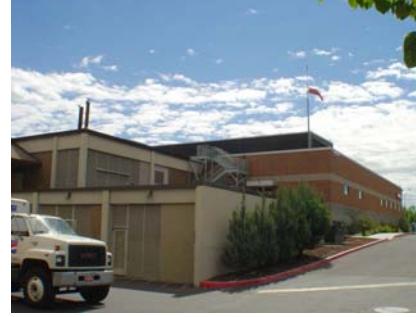
SE General Site		S Plan Irregularity Primary Also shows vertical a irregularity.

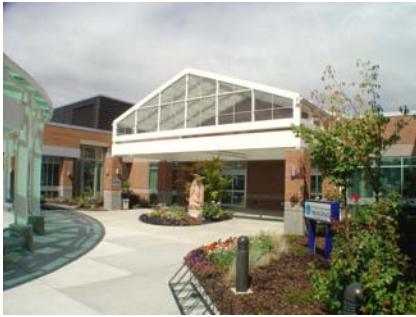
E Falling Hazard This metal overhead ornamental piece is not connected to the building.		E Vertical Irregularity Primary
