Rogue Valley Medical Center - Medford

Jack_hos03A

FEMA 154 Rapid Visual Screening Score Card

Rapid Visual Screening - Senate Bill #2 - Seismic Needs Assessment
Oregon Department of Geology and Mineral Industries

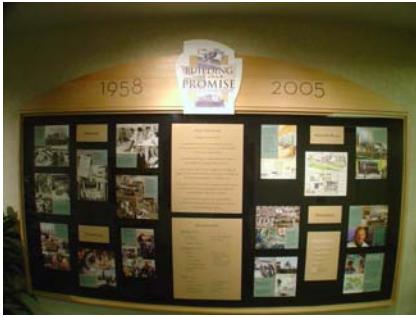
S Field Verified Year Built		S Plan Irregularity Primary

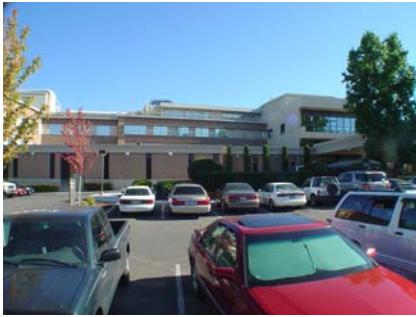
S Vertical Irregularity Primary

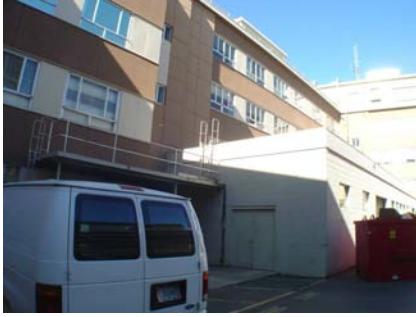
N Vertical Irregularity Primary

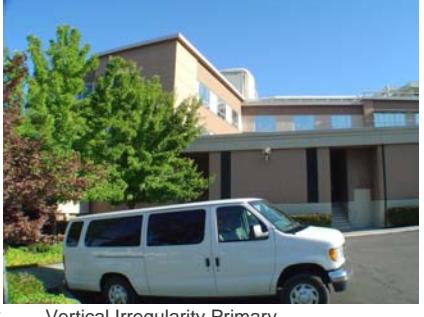
S Vertical Irregularity Primary

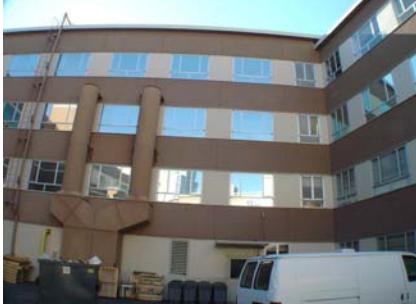
N Plan Irregularity Primary
