# Ashland High School

Ashland SD 5

Building Type School	County Jackson	
Street 201 S Mountain Ave		
City Ashland	State OR	Zip 97520
Latitude 42.19067	Longitude 122.69956	
Tracking Code SER & RVS2006	Inspection Date 7/24/2006

Rapid Visual Screening - Senate Bill #2 - Seismic Needs Assessment  
 Oregon Department of Geology and Mineral Industries

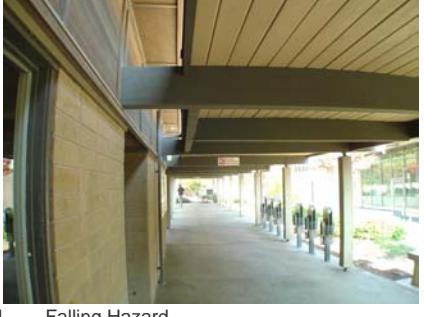
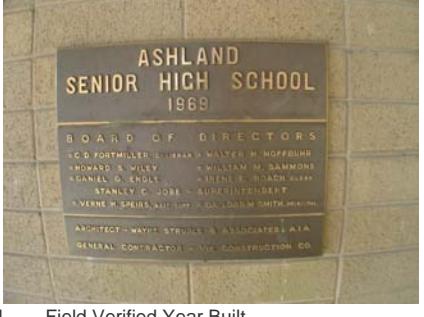
N Falling Hazard	N Field Verified Year Built

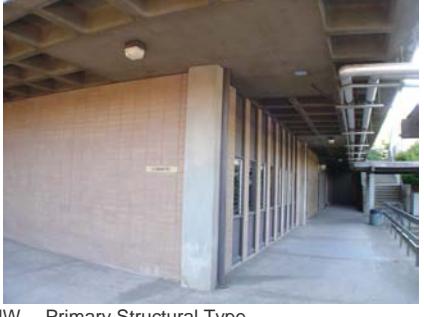
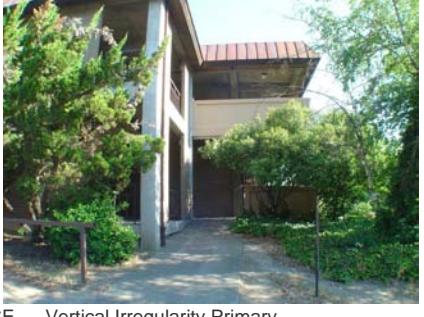
Enrollment 1123	Year Built (Field Verified) 1969	Year Built (Alt. Source) 1969	Est. Decade Built 1970
Total Area (square ft) 238735	Number of Stories 3	Basement	Pounding Potential No
<b>Plan Irregularities</b> Reentrant Corners: Other None None		<b>Vertical Irregularities</b> Building On Hill or Sloped Site None None	
<b>Falling Hazards</b> None None None		<b>Poor Conditions</b> None None None

NW Primary Structural Type		SE Vertical Irregularity Primary 2 stories compared to 3 on the first image.

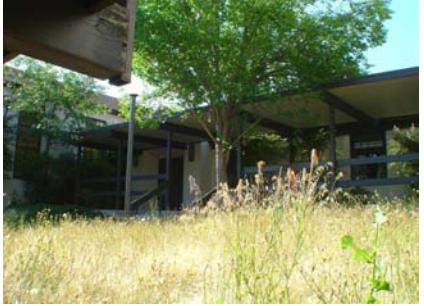
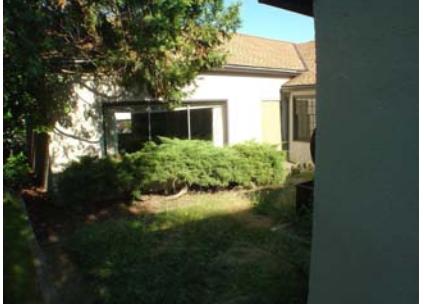
Enrollment 1123	Year Built (Field Verified) 1969	Year Built (Alt. Source) 1960	Est. Decade Built 1960
Total Area (square ft) 238735	Number of Stories 1	Basement	Pounding Potential No
Plan Irregularities Reentrant Corners: Other None None		Vertical Irregularities Steps in Elevation View: Single Change None None	
Falling Hazards None None Unreinforced Chimneys		Poor Conditions None None None

N General Site		S Plan Irregularity Primary

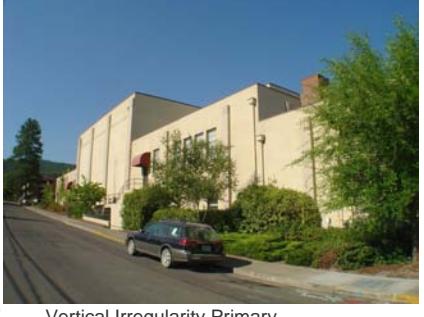
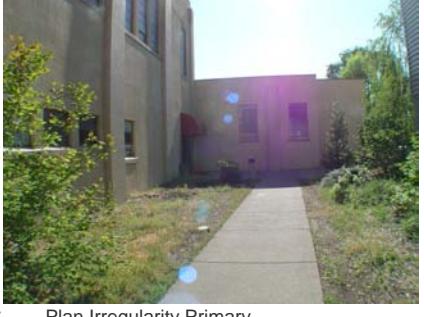
Enrollment 1123	Year Built (Field Verified) 1969	Year Built (Alt. Source) 1960	Est. Decade Built 1960
Total Area (square ft) 238735	Number of Stories 3	Basement	Pounding Potential No
Plan Irregularities		Vertical Irregularities	
Reentrant Corners: Other		Steps in Elevation View: Very Irregular Changes	
Non-Parallel System		Building On Hill or Sloped Site	
None		None	
Falling Hazards		Poor Conditions	
None		None	
None		None	
None		None

E Vertical Irregularity Primary And secondary vertical.		S Plan Irregularity Primary

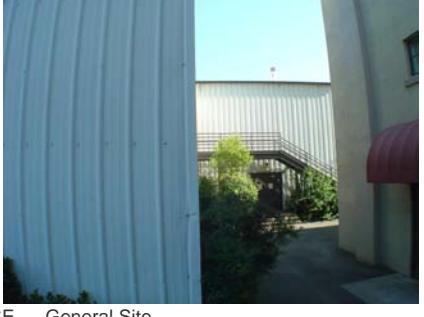
SE General Site

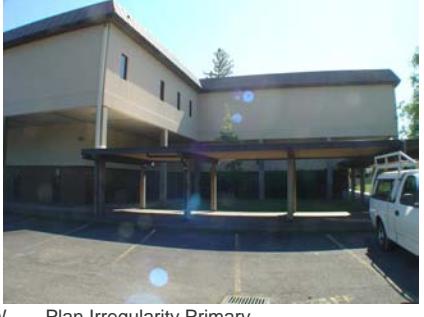
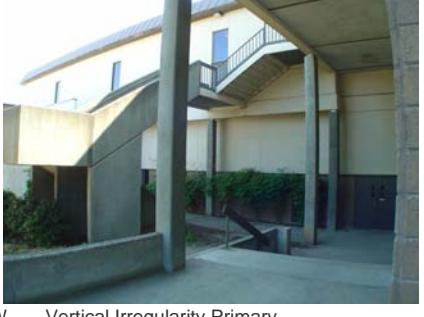
Enrollment 1123	Year Built (Field Verified) 1969	Year Built (Alt. Source) 1960	Est. Decade Built 1960
Total Area (square ft) 238735	Number of Stories 3	Basement	Pounding Potential No
<b>Plan Irregularities</b> Reentrant Corners: Other None None		<b>Vertical Irregularities</b> Building On Hill or Sloped Site Vertical Change in Structural Type (Soft over Stiff) None	
<b>Falling Hazards</b> None None None		<b>Poor Conditions</b> None None None

W Plan Irregularity Primary	W Vertical Irregularity Primary 3 stories can be seen in this image.	E General Site

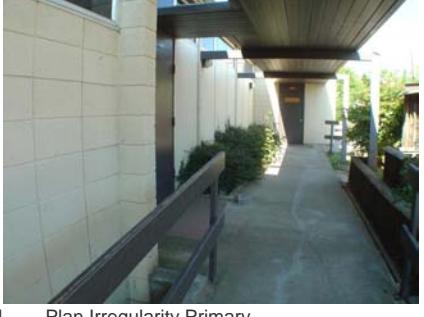
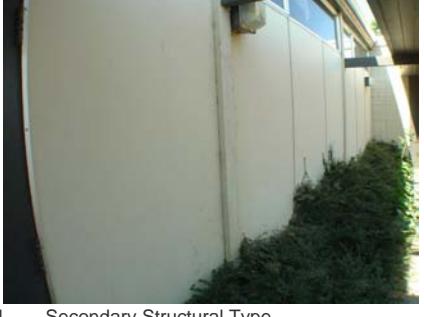
Enrollment 1123	Year Built (Field Verified) 1969	Year Built (Alt. Source) 1969	Est. Decade Built 1970
Total Area (square ft) 238735	Number of Stories 1	Basement	Pounding Potential No
Plan Irregularities Out of Plane Lateral-Force-Resistance Elements None None		Vertical Irregularities Steps in Elevation View: Single Change None None	
Falling Hazards None None None		Poor Conditions None None None

N Plan Irregularity Primary		N Secondary Structural Type
