Patrick Elementary School

Central Point SD 6

FEMA 154 Rapid Visual Screening Score Card

Rapid Visual Screening - Senate Bill #2 - Seismic Needs Assessment
Oregon Department of Geology and Mineral Industries

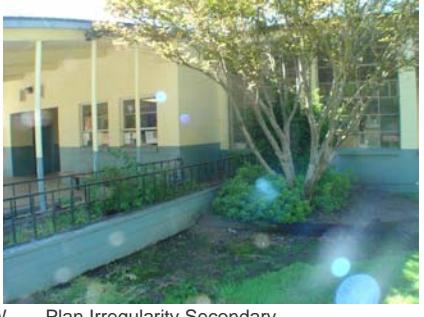
Enrollment 268	Year Built (Field Verified) 1956	Year Built (Alt. Source) 1956	Est. Decade Built 1950
Total Area (square ft) 35004	Number of Stories 1	Basement	Pounding Potential No
Plan Irregularities		Vertical Irregularities	
Reentrant Corners: L Shaped		Steps in Elevation View: Very Irregular Changes	
Out of Plane Lateral-Force-Resistance Elements		None	
None		None	
Falling Hazards		Poor Conditions	
None		None	
None		None	
None		None

W Plan Irregularity Secondary	NE Vertical Irregularity Primary	N General Site

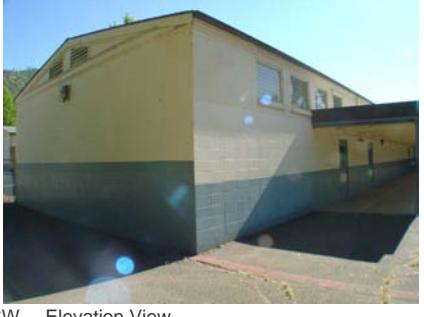
SW Elevation View

Enrollment 268	Year Built (Field Verified) 1956	Year Built (Alt. Source) 1956	Est. Decade Built 1950
Total Area (square ft) 35004	Number of Stories 1	Basement	Pounding Potential No
Plan Irregularities Torsion: Eccentric Stiffness None None		Vertical Irregularities None None None	
Falling Hazards None None None		Poor Conditions None None None
