Hanby Middle School

Jack_sch13A

FEMA 154 Rapid Visual Screening Score Card

Rapid Visual Screening - Senate Bill #2 - Seismic Needs Assessment
Oregon Department of Geology and Mineral Industries

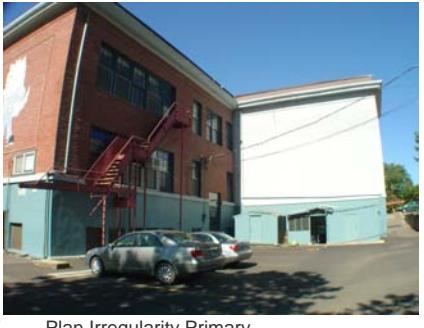
E	Plan Irregularity Primary	S	Plan Irregularity Secondary

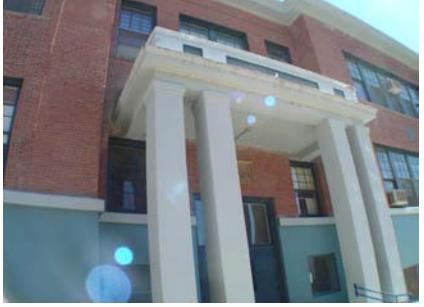
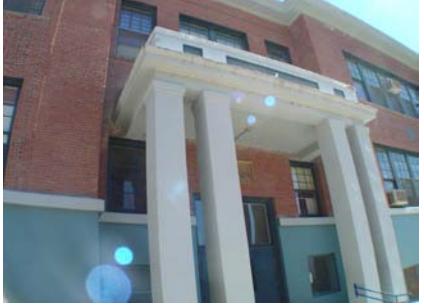
Enrollment 275	Year Built (Field Verified) 1910	Year Built (Alt. Source) 1910	Est. Decade Built 1910
Total Area (square ft) 38449	Number of Stories 3	Basement	Pounding Potential No
Plan Irregularities		Vertical Irregularities	
Reentrant Corners: L Shaped		None	
Out of Plane Lateral-Force-Resistance Elements		None	
None		None	
Falling Hazards		Poor Conditions	
Other: Ornamental Hazard Over Exit		None	
None		None	
None		None

S	Falling Hazard	S	Falling Hazard

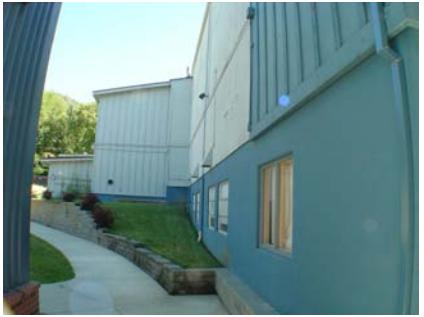
SW Plan Irregularity Primary also shows sloped site.		W Vertical Irregularity Primary also shows reentrant corner.

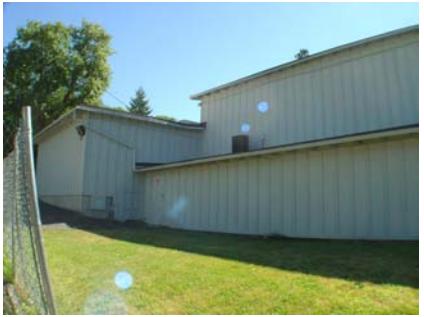
Enrollment 275	Year Built (Field Verified) 1910	Year Built (Alt. Source) 1940	Est. Decade Built 1940
Total Area (square ft) 38449	Number of Stories 2	Basement No	Pounding Potential No
Plan Irregularities Reentrant Corners: Other None None		Vertical Irregularities Steps in Elevation View: 2 to 3 Changes Building On Hill or Sloped Site None	
Falling Hazards None None None		Poor Conditions None None None
