Scenic Middle School

Jack_sch14A

FEMA 154 Rapid Visual Screening Score Card

Rapid Visual Screening - Senate Bill #2 - Seismic Needs Assessment
Oregon Department of Geology and Mineral Industries

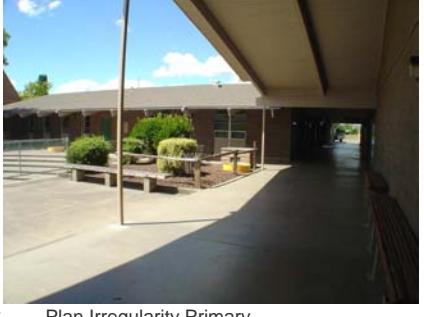
S	Plan Irregularity Primary	W	General Site

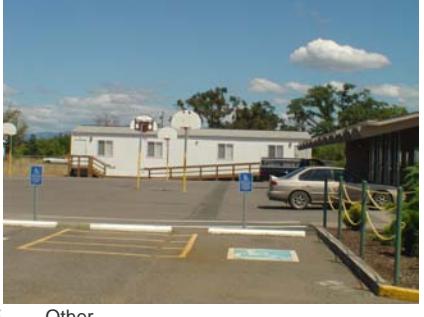
E	Other Modular

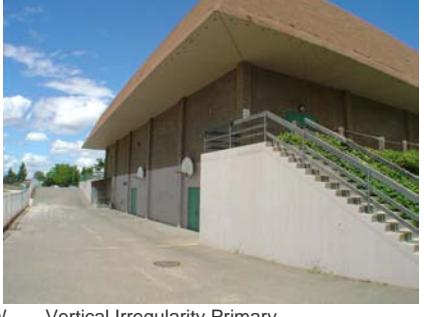
High (>10%)

W Vertical Irregularity Primary sloped site.

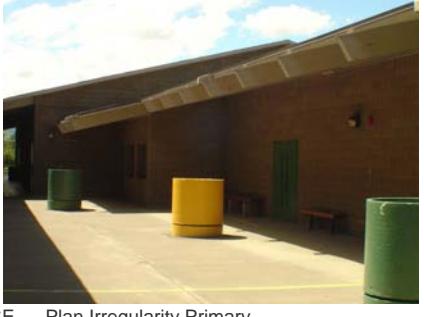
SE Plan Irregularity Primary Reentrant corner.		N General Site
