Crater High School

Central Point SD 6

FEMA 154 Rapid Visual Screening Score Card

Rapid Visual Screening - Senate Bill #2 - Seismic Needs Assessment
Oregon Department of Geology and Mineral Industries

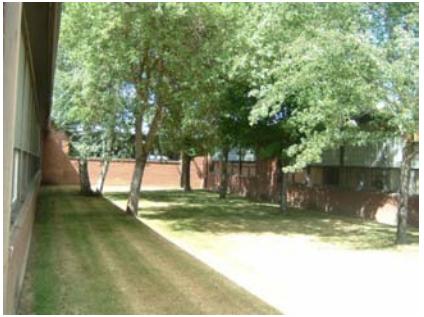
S Plan Irregularity Primary

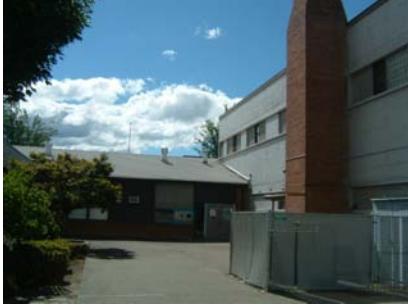
S Falling Hazard		S Vertical Irregularity Primary also shows reentrant corner

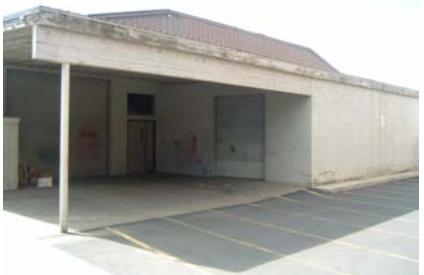
<p>SE Plan Irregularity Primary vertical also</p>

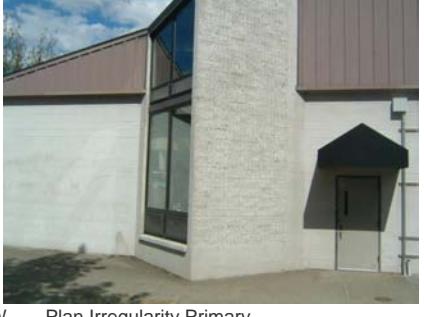
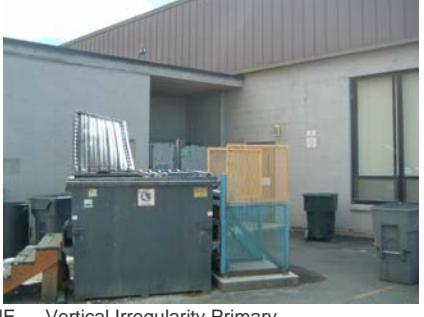
W Plan Irregularity Primary		NE Vertical Irregularity Primary also shows reentrant corner.

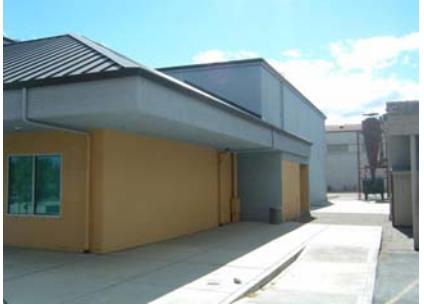
NE Vertical Irregularity Primary

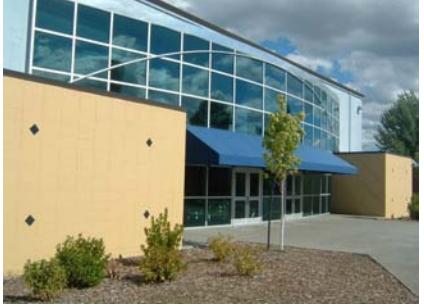
W General Site also shows reentrant corners and vertical irregularity.
