# Rogue River High School

Jack\_sch22A

## FEMA 154 Rapid Visual Screening Score Card

Rapid Visual Screening - Senate Bill #2 - Seismic Needs Assessment  
Oregon Department of Geology and Mineral Industries

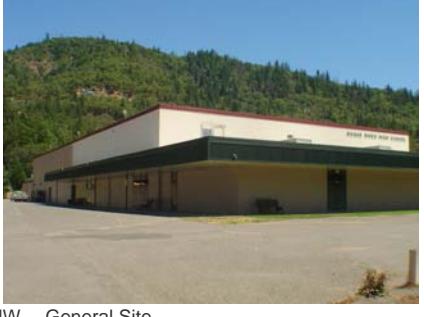
NW General Site		W General Site
