# Griffin Creek Elementary School

Medford SD 549C

## FEMA 154 Rapid Visual Screening Score Card

Rapid Visual Screening - Senate Bill #2 - Seismic Needs Assessment  
Oregon Department of Geology and Mineral Industries

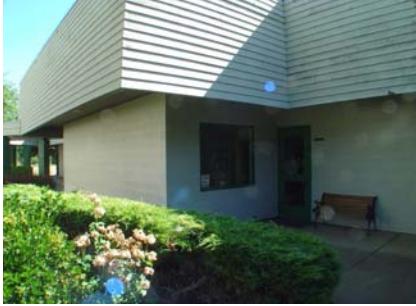
W Plan Irregularity Primary Minor reentrant corner.

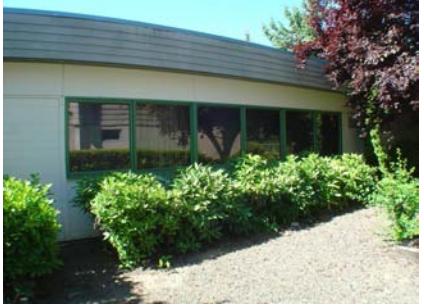
W Plan Irregularity Primary west side is all wood

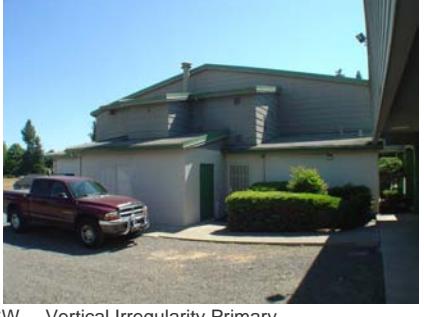
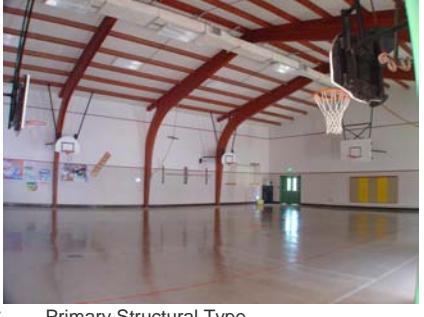
SW Vertical Irregularity Primary also shows plan irregularity.		S Primary Structural Type

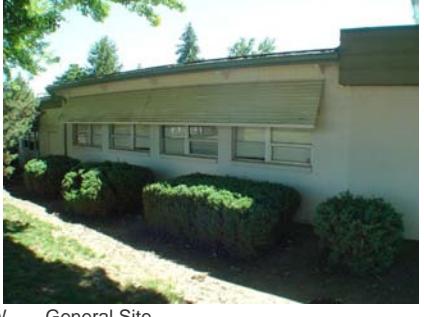
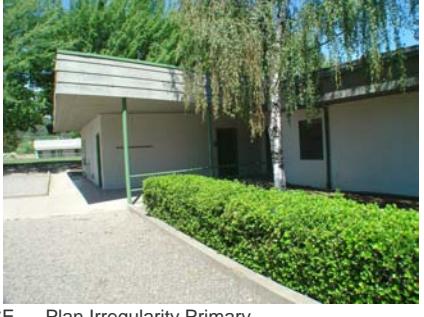
W    General Site Masonry wall, vertical irregularity can also be seen.		SE    Plan Irregularity Primary	
		E    Plan Irregularity Primary
