Hoover Elementary School

Medford SD 549C

FEMA 154 Rapid Visual Screening Score Card

Rapid Visual Screening - Senate Bill #2 - Seismic Needs Assessment
Oregon Department of Geology and Mineral Industries

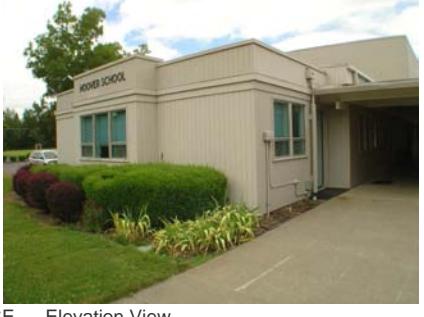
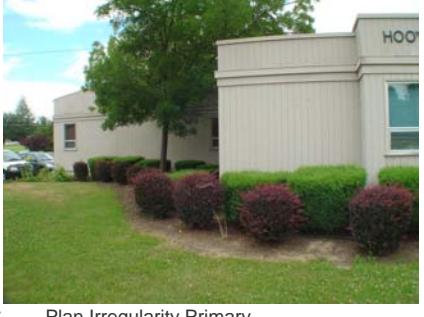
Enrollment 484	Year Built (Field Verified) 1958	Year Built (Alt. Source) 1958	Est. Decade Built 1960
Total Area (square ft) 51611	Number of Stories 1	Basement	Pounding Potential No
Plan Irregularities		Vertical Irregularities	
Reentrant Corners: Other		None	
Out of Plane Lateral-Force-Resistance Elements		None	
None		None	
Falling Hazards		Poor Conditions	
None		None	
None		None	
None		None

SE Elevation View also shows an out of plane lateral system.		S Plan Irregularity Primary

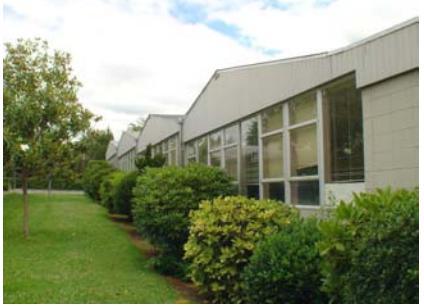
Enrollment 484	Year Built (Field Verified) 1958	Year Built (Alt. Source) 1958	Est. Decade Built 1960
Total Area (square ft) 51611	Number of Stories 1	Basement	Pounding Potential No
Plan Irregularities None None None		Vertical Irregularities Building On Hill or Sloped Site Steps in Elevation View: 2 to 3 Changes None	
Falling Hazards None None None		Poor Conditions None None None

N Plan Irregularity Primary Three walls are RM1 and one is wood.

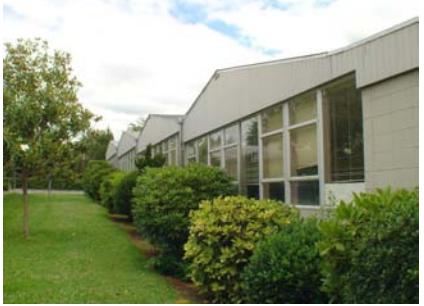
Enrollment 484	Year Built (Field Verified) 1958	Year Built (Alt. Source) 1958	Est. Decade Built 1960
Total Area (square ft) 51611	Number of Stories 1	Basement	Pounding Potential No
Plan Irregularities None None None		Vertical Irregularities Building On Hill or Sloped Site Steps in Elevation View: 2 to 3 Changes None	
Falling Hazards None None None		Poor Conditions None None None

N Plan Irregularity Primary

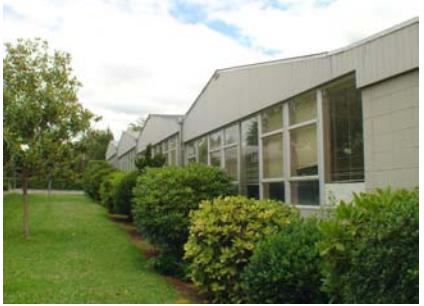
Enrollment 484	Year Built (Field Verified) 1958	Year Built (Alt. Source) 1958	Est. Decade Built 1960
Total Area (square ft) 51611	Number of Stories 1	Basement	Pounding Potential No
Plan Irregularities None None None		Vertical Irregularities Building On Hill or Sloped Site Steps in Elevation View: 2 to 3 Changes None	
Falling Hazards None None None		Poor Conditions None None None

N Plan Irregularity Primary

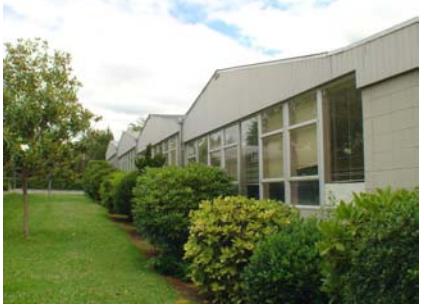
Enrollment 484	Year Built (Field Verified) 1958	Year Built (Alt. Source) 1958	Est. Decade Built 1960
Total Area (square ft) 51611	Number of Stories 1	Basement	Pounding Potential No
Plan Irregularities None None None		Vertical Irregularities Building On Hill or Sloped Site Steps in Elevation View: 2 to 3 Changes None	
Falling Hazards None None None		Poor Conditions None None None

N Plan Irregularity Primary

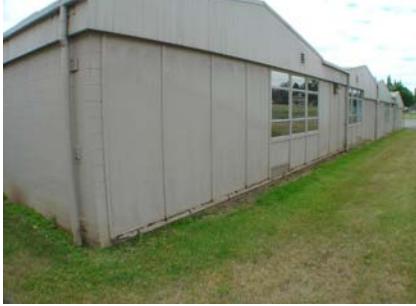
Enrollment 484	Year Built (Field Verified) 1958	Year Built (Alt. Source) 1958	Est. Decade Built 1960
Total Area (square ft) 51611	Number of Stories 1	Basement	Pounding Potential No
Plan Irregularities Torsion: Building Shape None None		Vertical Irregularities None None None	
Falling Hazards None None None		Poor Conditions None None None

<p>NE Elevation View shows a RM wall on the left and a W2 wall on the right.</p>

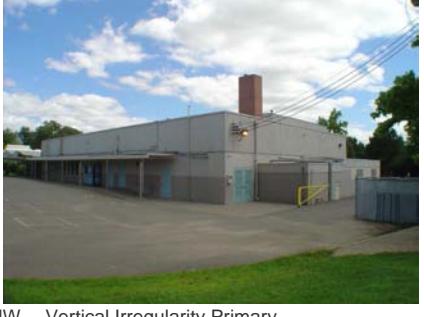
Enrollment 484	Year Built (Field Verified) 1958	Year Built (Alt. Source) 1958	Est. Decade Built 1960
Total Area (square ft) 51611	Number of Stories 1	Basement	Pounding Potential No
Plan Irregularities Reentrant Corners: Other None None		Vertical Irregularities Steps in Elevation View: Very Irregular Changes None None	
Falling Hazards Unreinforced Chimneys None None		Poor Conditions None None None

NW Vertical Irregularity Primary
