Howard Elementary School

Jack_sch25A

FEMA 154 Rapid Visual Screening Score Card

Rapid Visual Screening - Senate Bill #2 - Seismic Needs Assessment
Oregon Department of Geology and Mineral Industries

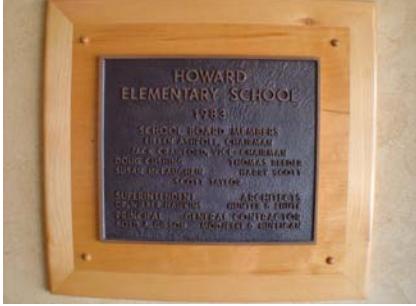
NE Field Verified Year Built

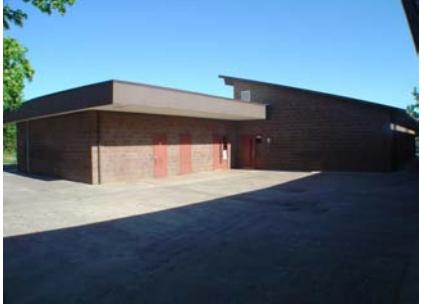
SE Plan Irregularity Primary Also shows an elevation step.

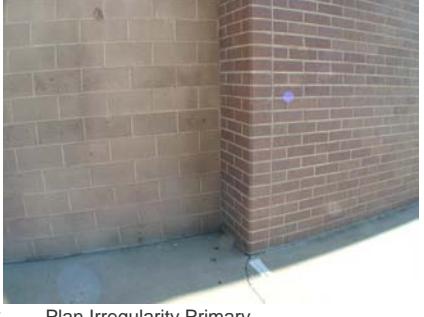
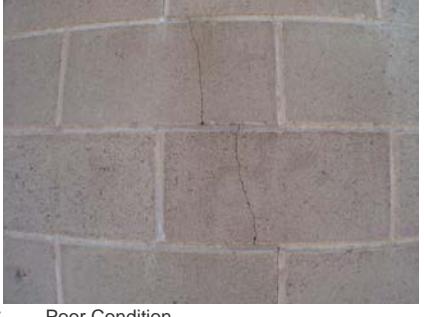
S Plan Irregularity Primary This is due to newer building.		S Poor Condition There are cracks all over.

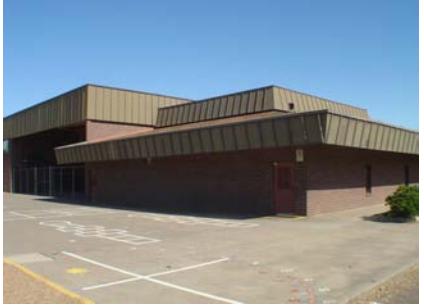
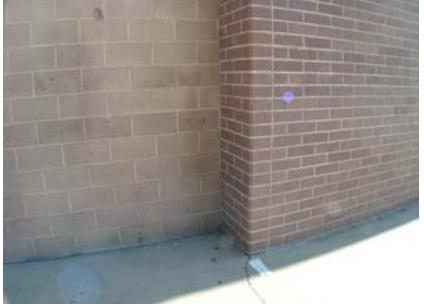
SE Vertical Irregularity Primary		S Plan Irregularity Primary
