Jackson Elementary School

Medford SD 549C

FEMA 154 Rapid Visual Screening Score Card

Rapid Visual Screening - Senate Bill #2 - Seismic Needs Assessment
Oregon Department of Geology and Mineral Industries

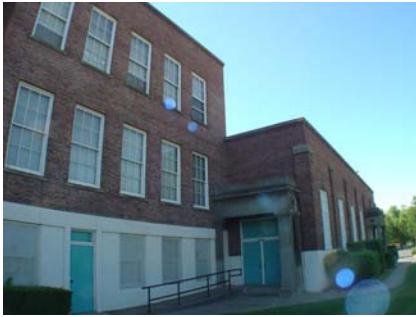
| E Vertical Irregularity Primary also shows reentrant corner. | | E Poor Condition Cracks and poor masonry | |

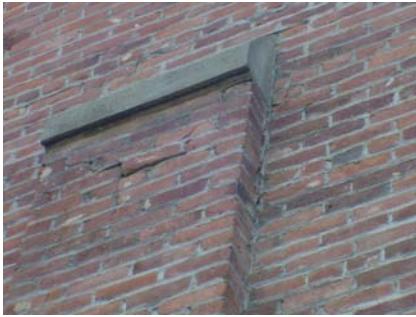
| Parapets: Unreinforced Around Entire Building | | Cracks | |
| None | | Poor Masonry | |

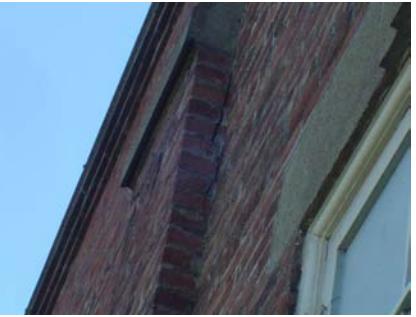
| | | E Poor Condition | |

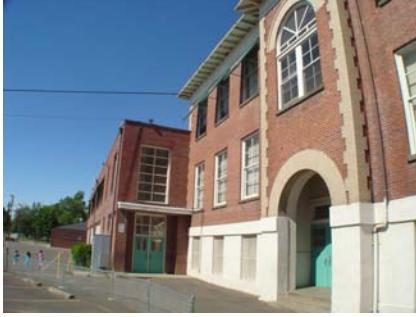
| W Plan Irregularity Tertiary The building on the left is a new addition. | | S Falling Hazard | |

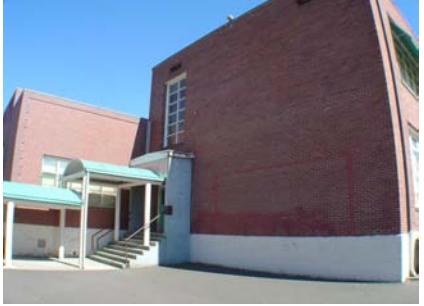
| W Vertical Irregularity Primary With "C" | | | |
