Lone Pine Elementary School

Medford SD 549C

FEMA 154 Rapid Visual Screening Score Card

Rapid Visual Screening - Senate Bill #2 - Seismic Needs Assessment
Oregon Department of Geology and Mineral Industries

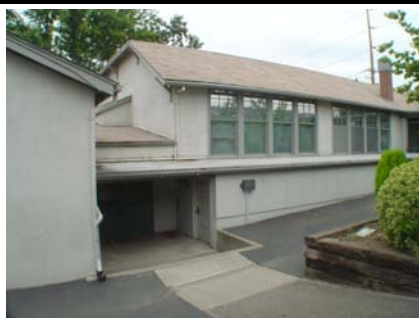
E Elevation View

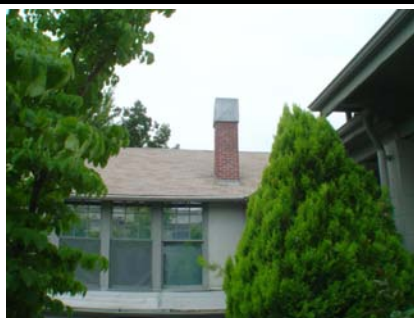
E Falling Hazard

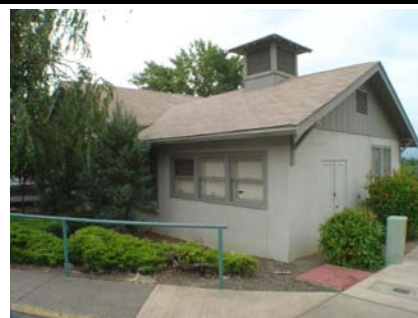
NE Elevation View

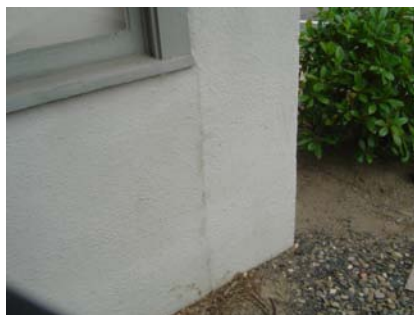
NW Primary Structural Type

A concrete column can clearly be seen here by the cracks separating it from the wood siding.

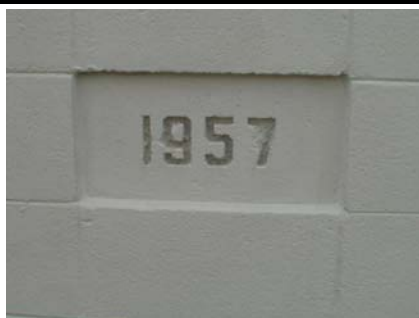
NE Field Verified Year Built

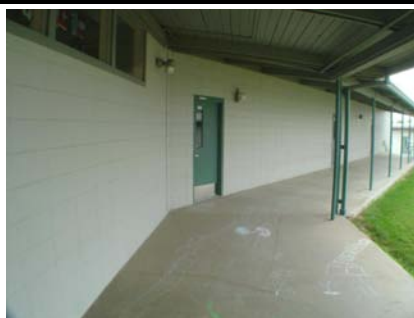
W Plan Irregularity Primary

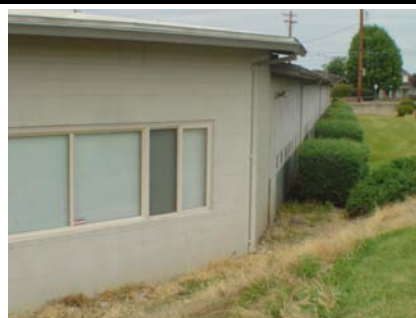
W Plan Irregularity Primary

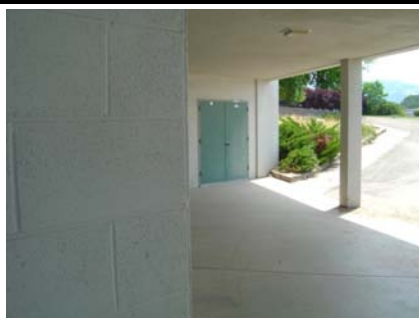
W Secondary Structural Type

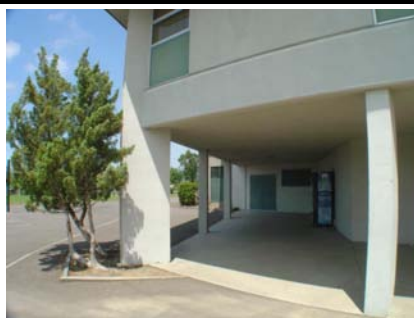
W Primary Structural Type

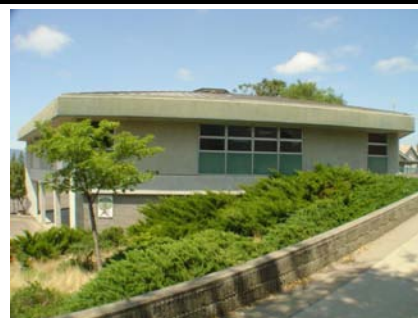
S Vertical Irregularity Primary
sloped site

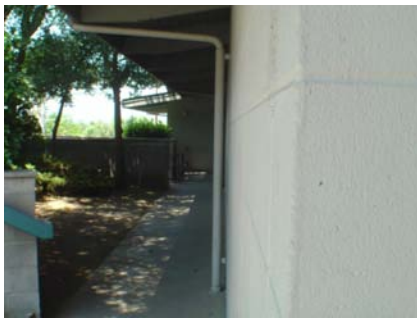
SW Plan Irregularity Primary

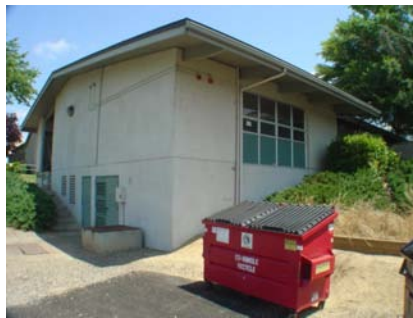
SW Vertical Irregularity Secondary
sloped site
