Oak Grove Elementary School

Medford SD 549C

FEMA 154 Rapid Visual Screening Score Card

Rapid Visual Screening - Senate Bill #2 - Seismic Needs Assessment
Oregon Department of Geology and Mineral Industries

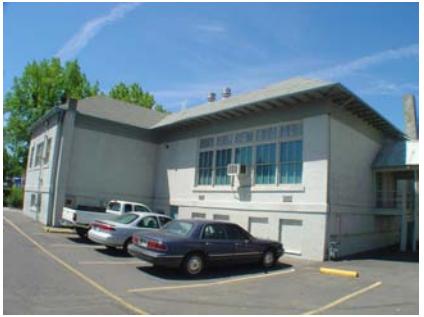
NE Plan Irregularity Primary	NE Secondary Structural Type	NW Plan Irregularity Secondary

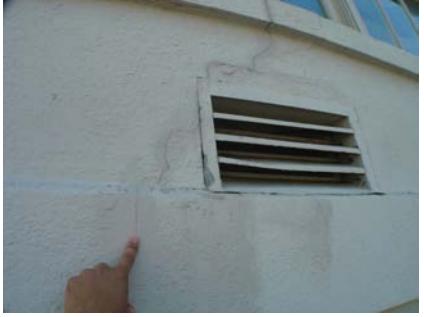
Enrollment 455	Year Built (Field Verified) 1891	Year Built (Alt. Source) 1891	Est. Decade Built Pre 1900
Total Area (square ft) 47329	Number of Stories 2	Basement	Pounding Potential No
Plan Irregularities		Vertical Irregularities	
Reentrant Corners: Other		Steps in Elevation View: Single Change (Adjacent Building/Entity)	
Reentrant Corners: Other		None	
None		None	
Falling Hazards		Poor Conditions	
None		Poor Masonry	
None		Poor Concrete	
None		None

NE General Site	W Poor Condition

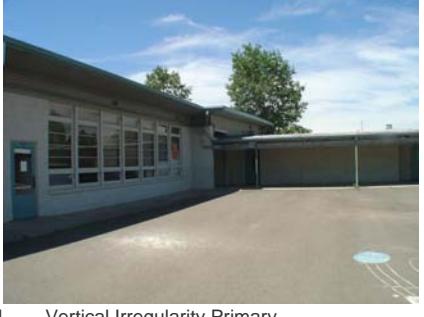
Enrollment 455	Year Built (Field Verified) 1891	Year Built (Alt. Source) 1891	Est. Decade Built 1940
Total Area (square ft) 47329	Number of Stories 1	Basement	Pounding Potential No
Plan Irregularities		Vertical Irregularities	
Out of Plane Lateral-Force-Resistance Elements		Steps in Elevation View: 2 to 3 Changes (Adjacent Building/Entity)	
Reentrant Corners: L Shaped		None	
None		None	
Falling Hazards		Poor Conditions	
None		None	
None		None	
None		None

N Vertical Irregularity Primary .Plan Irregularity Secondary

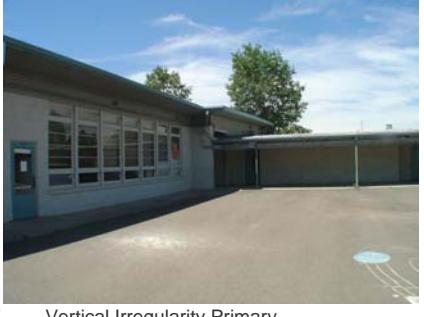
Enrollment 455	Year Built (Field Verified) 1891	Year Built (Alt. Source) 1891	Est. Decade Built 1940
Total Area (square ft) 47329	Number of Stories 1	Basement	Pounding Potential No
Plan Irregularities Reentrant Corners:L shaped (Adjacent Build/Entity) None None		Vertical Irregularities Steps in Elevation View: Single Change (Adjacent Building/Entity) None None	
Falling Hazards None None None		Poor Conditions None None None

<p>E Vertical Irregularity Primary Plan Irregularity</p>

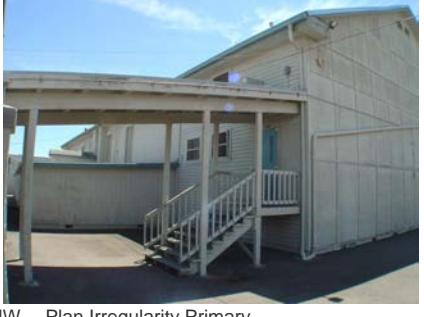
Enrollment 455	Year Built (Field Verified) 1891	Year Built (Alt. Source) 1891	Est. Decade Built 1930
Total Area (square ft) 47329	Number of Stories 1	Basement	Pounding Potential No
Plan Irregularities Reentrant Corners: Other None None		Vertical Irregularities Steps in Elevation View: Single Change None None	
Falling Hazards Unreinforced Chimneys None None		Poor Conditions None None None

NW Plan Irregularity Primary

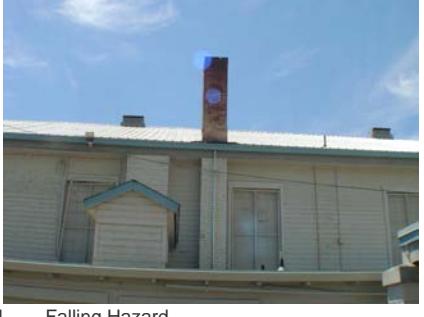
N Falling Hazard

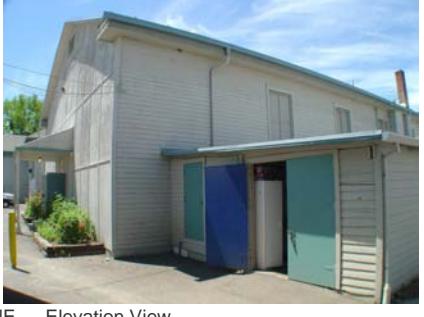
NE Elevation View

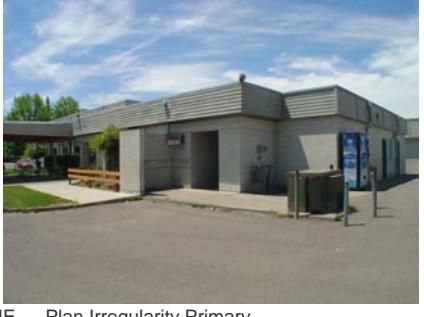
Enrollment 455	Year Built (Field Verified) 1891	Year Built (Alt. Source) 1891	Est. Decade Built 1950
Total Area (square ft) 47329	Number of Stories 1	Basement	Pounding Potential No
Plan Irregularities Out of Plane Lateral-Force-Resistance Elements None None		Vertical Irregularities None None None	
Falling Hazards None None None		Poor Conditions None None None

NE Plan Irregularity Primary
