# Roosevelt Elementary School

Medford SD 549C

Jack\_sch32A

Rapid Visual Screening - Senate Bill #2 - Seismic Needs Assessment  
Oregon Department of Geology and Mineral Industries

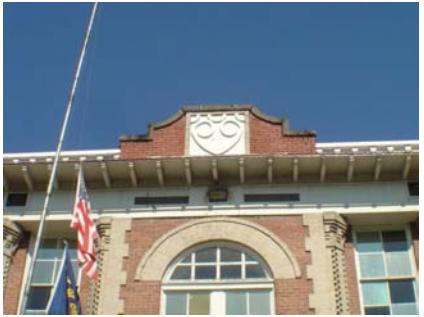
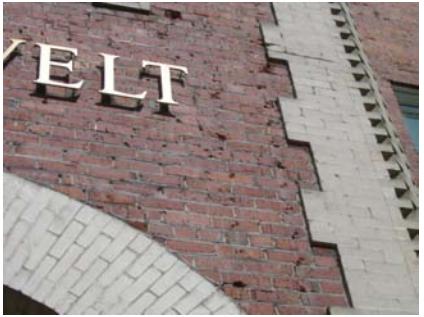
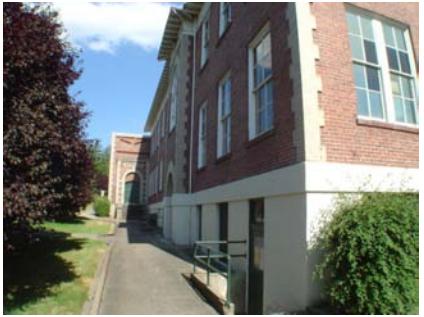
W Falling Hazard	W Poor Condition	NW Elevation View

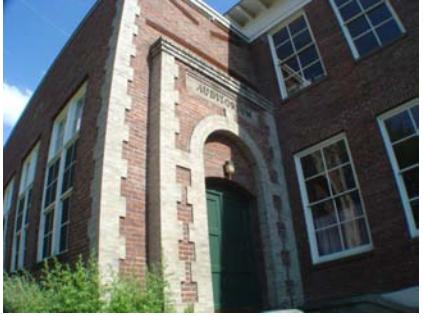
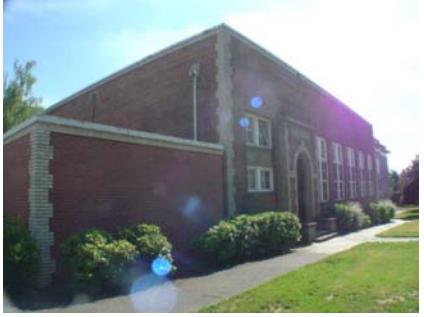
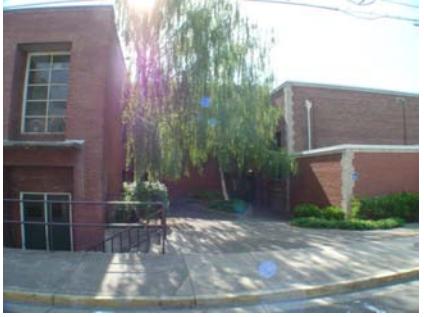
N Falling Hazard	NE Vertical Irregularity Primary	E Vertical Irregularity Primary

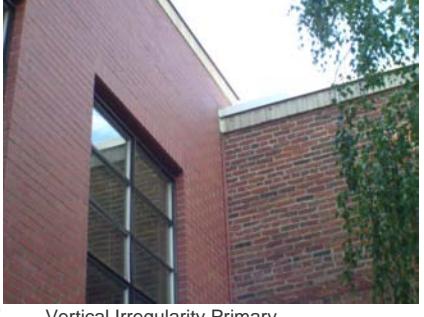
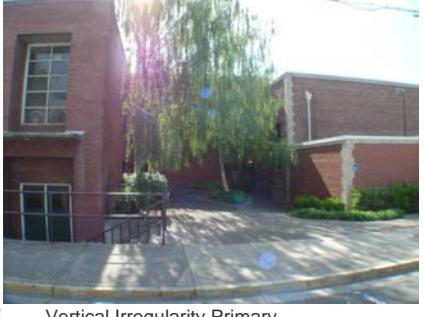
E Vertical Irregularity Primary To building "A". Also shows a reentrant corner.		E Vertical Irregularity Primary

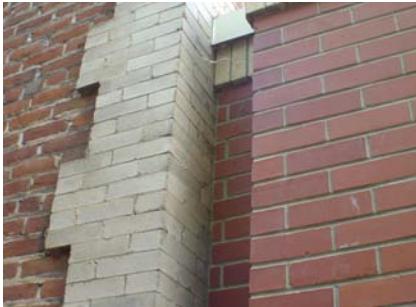
<p>S      Other Joint to "A"</p>
