# Washington Elementary School

Jack\_sch33A

## FEMA 154 Rapid Visual Screening Score Card

Rapid Visual Screening - Senate Bill #2 - Seismic Needs Assessment  
Oregon Department of Geology and Mineral Industries

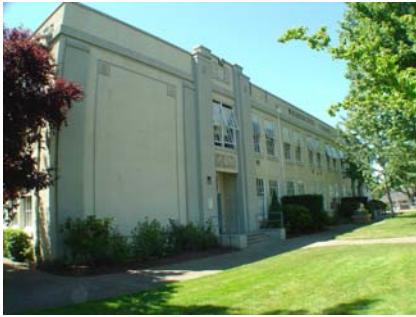
SE Elevation View		E Falling Hazard

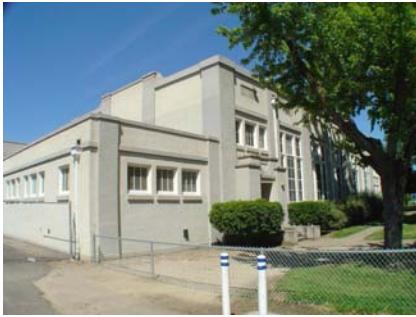
SW Vertical Irregularity Secondary		SW Vertical Irregularity Primary

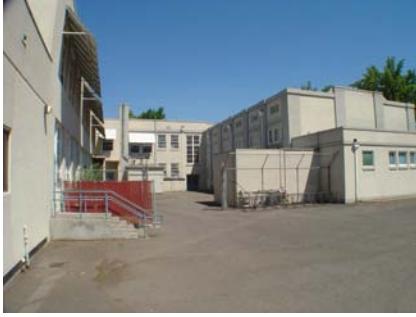
<p>W Plan Irregularity Primary and plan irregularity: reentrant corner due to adjacent building.</p>

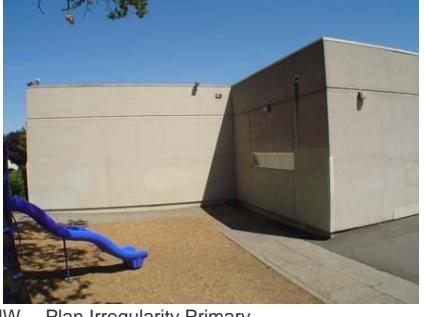
NW Plan Irregularity Primary

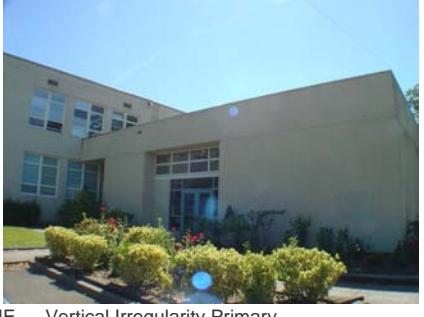
NE Vertical Irregularity Primary
