Hedrick Middle School

Medford SD 549C

Jack_sch34A

Rapid Visual Screening - Senate Bill #2 - Seismic Needs Assessment
Oregon Department of Geology and Mineral Industries

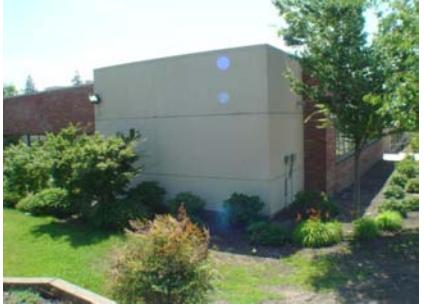
NE	Plan Irregularity Secondary		
N	Other Joint to building D

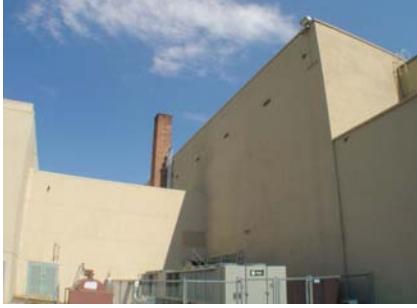
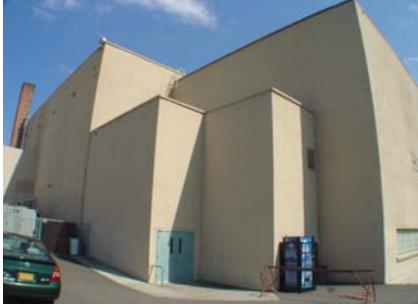
NW Falling Hazard		NW Elevation View elevation step and reentrant corner.

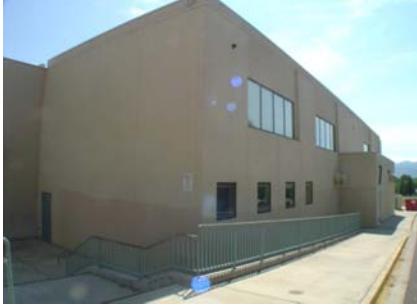
NE Elevation View

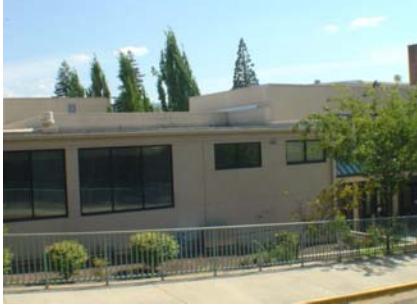
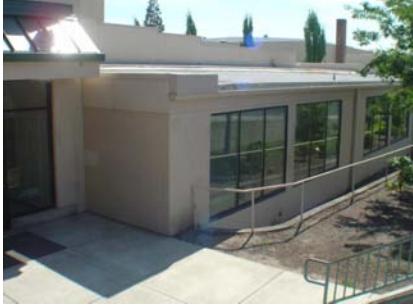
N Vertical Irregularity Primary		N Vertical Irregularity Primary
