South Medford High School

Medford SD 549C

FEMA 154 Rapid Visual Screening Score Card

Rapid Visual Screening - Senate Bill #2 - Seismic Needs Assessment
Oregon Department of Geology and Mineral Industries

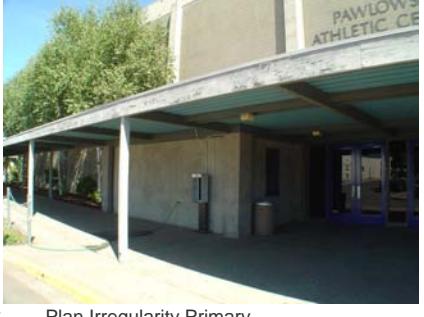
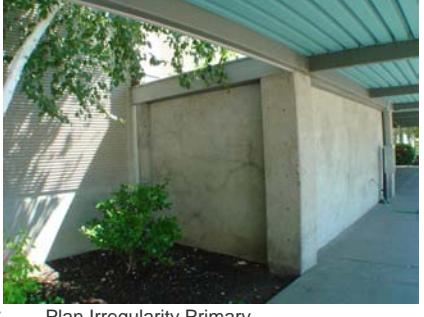
S Plan Irregularity Primary reentrant corner		S Plan Irregularity Primary reentrant corner

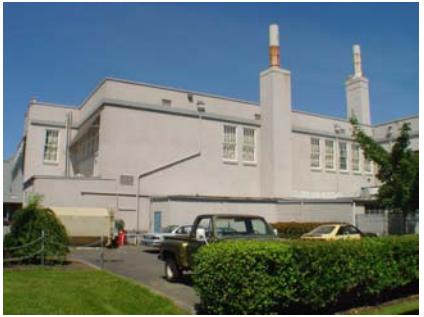
S Falling Hazard

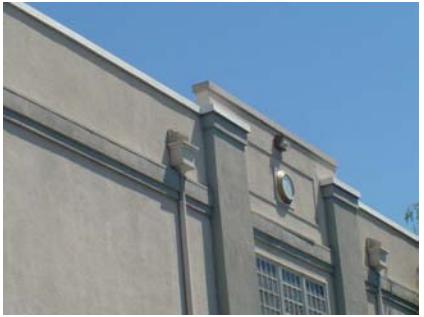
S Falling Hazard big parapet

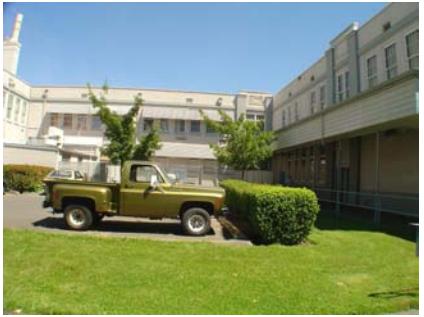
S Plan Irregularity Primary

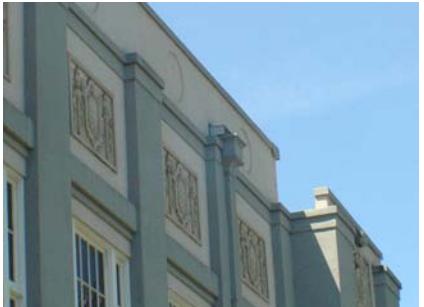
N Falling Hazard

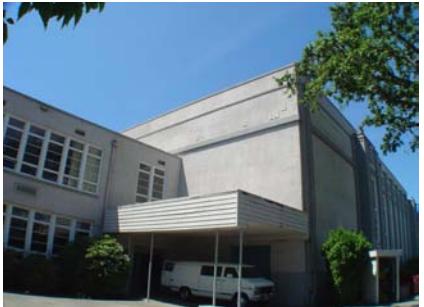
NE Vertical Irregularity Secondary Also plan irreg.

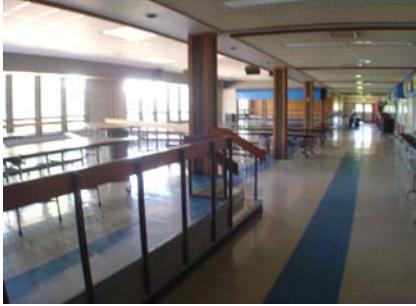
W Vertical Irregularity Primary Very large opening inside.

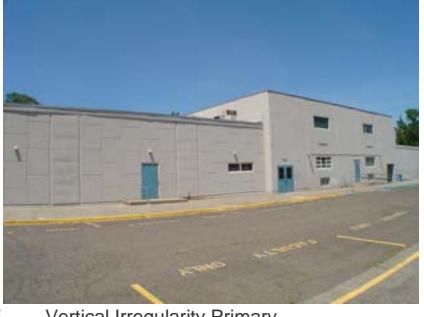
N Elevation View		E Vertical Irregularity Primary
